Barclay Park Condominium

Inspected: August 6, 2024 • Revised on: May 23, 2025
Ann Arbor, MI

RESERVE STUDY

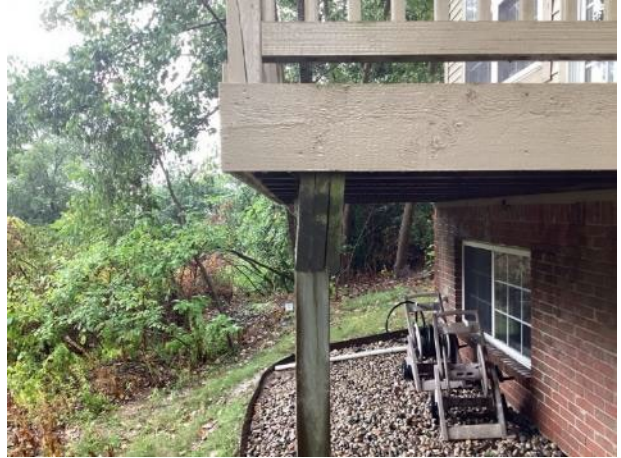
Beam cracks (unit 2968 shown)

Beam deflection (unit 2958 shown)

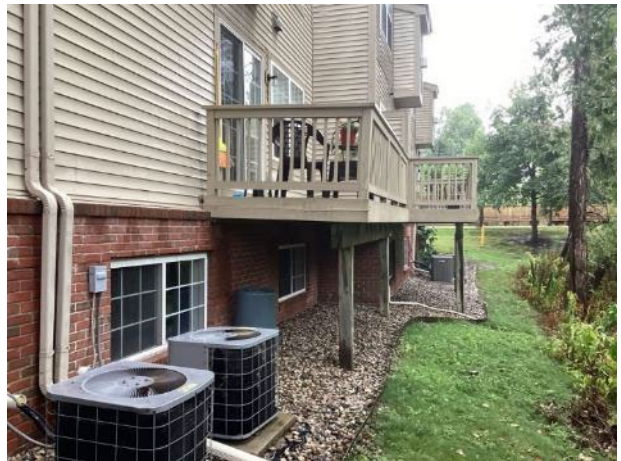
Beam cracks

Balcony settlement (unit 2972 shown)

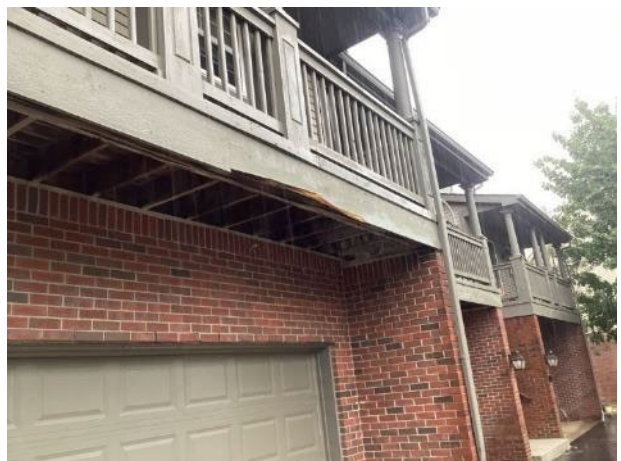
Balcony trim rot

Damage (unit 3046 shown)

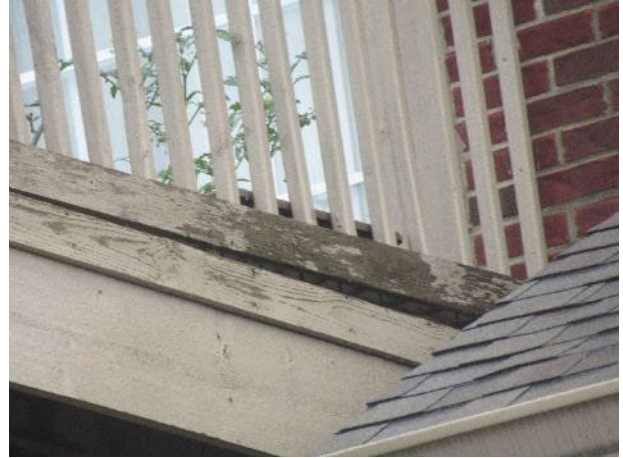
Balcony settlement

Finish deterioration

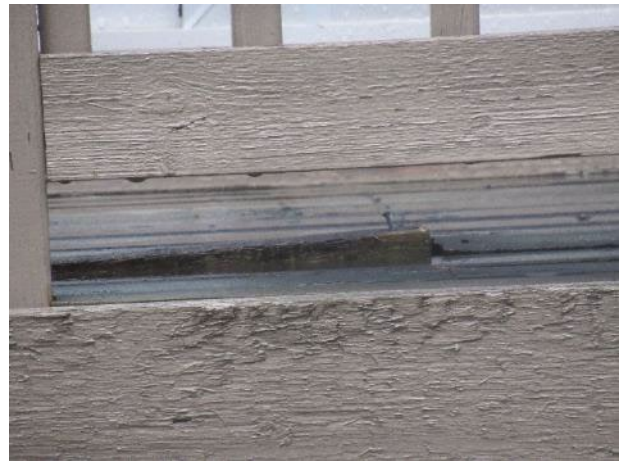
Balcony railing rot (unit 2793 shown)

Deck board deflection (unit 2839 shown)

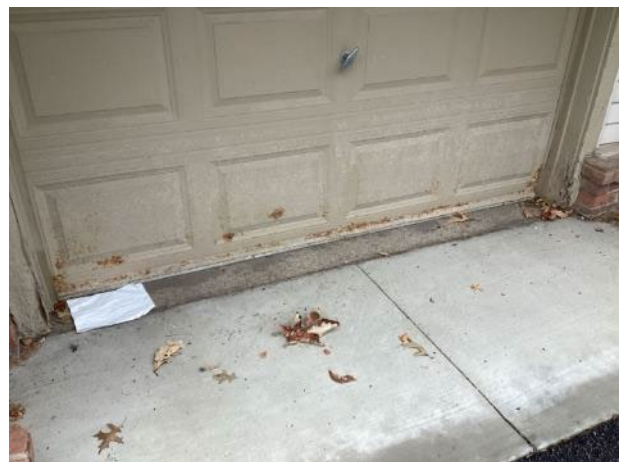
Base panel rust

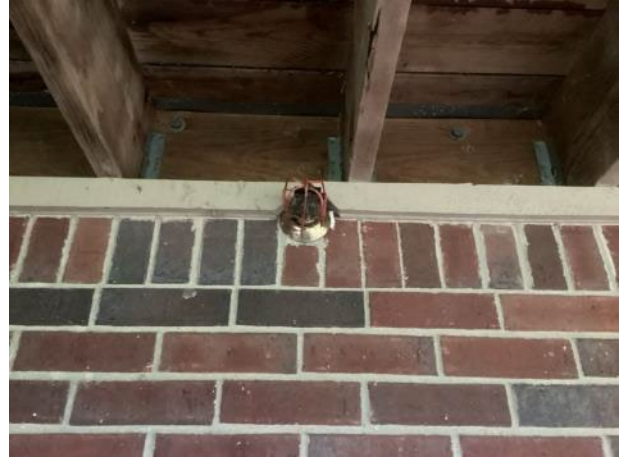
Corroded sprinkler head

Sprinkler head

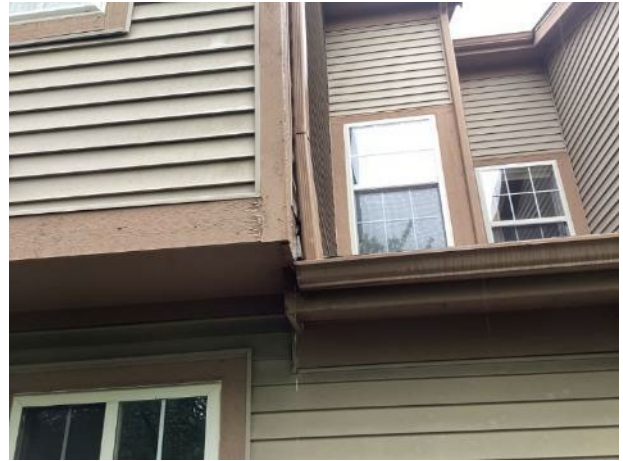
Gutter deflection (garage shown)

Downspout leakage (unit 2804 shown)

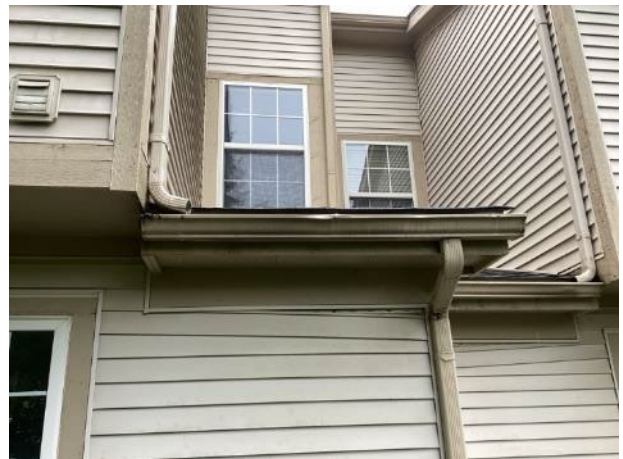
Leakage (unit 2812 shown)

Gutter sloped away from downspout

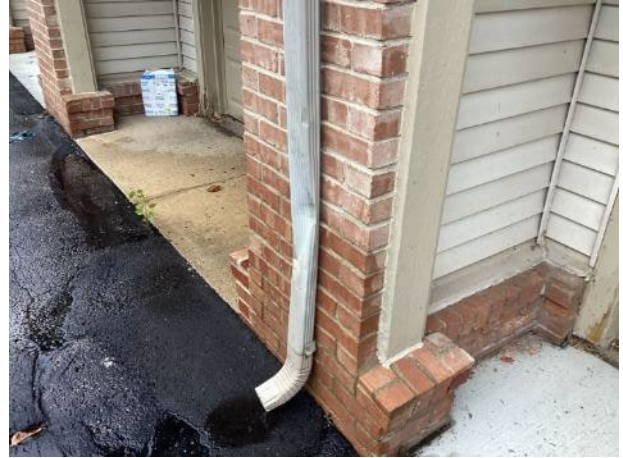
Gutter deflection (unit 2858 shown)

Damage (unit 2846 shown)

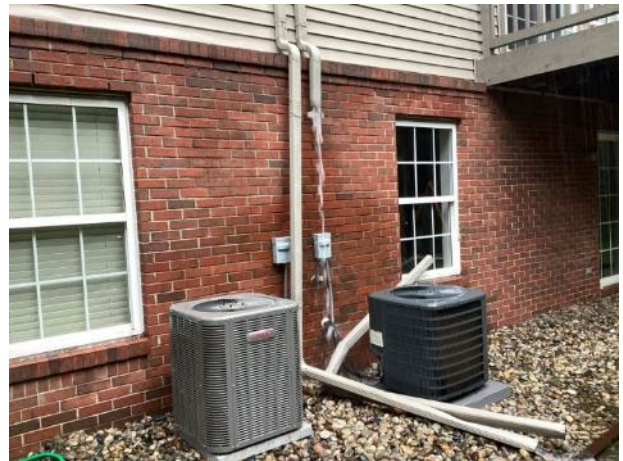
Gutter sloped away from downspout

Missing downspout extension (unit 3044 shown)

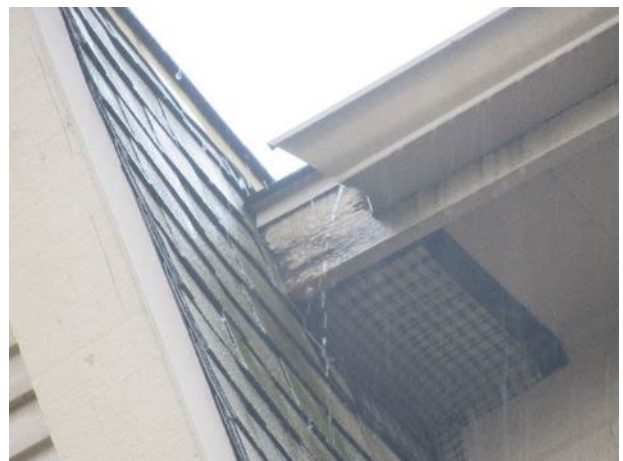
Missing gutter and downspout (unit 2723 shown)

Damage (unit 2764 shown)

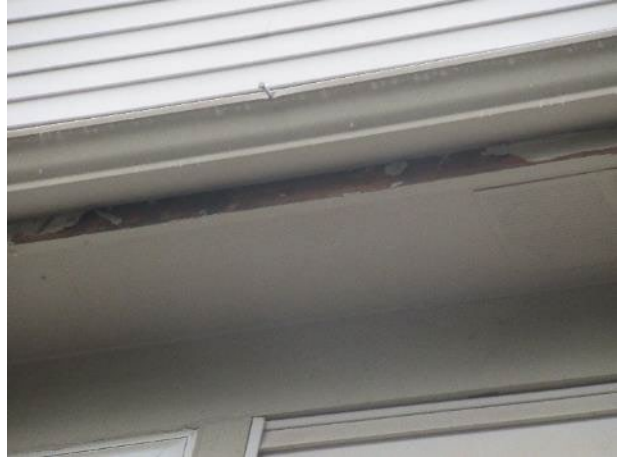
Loose fasteners

Loose fastener

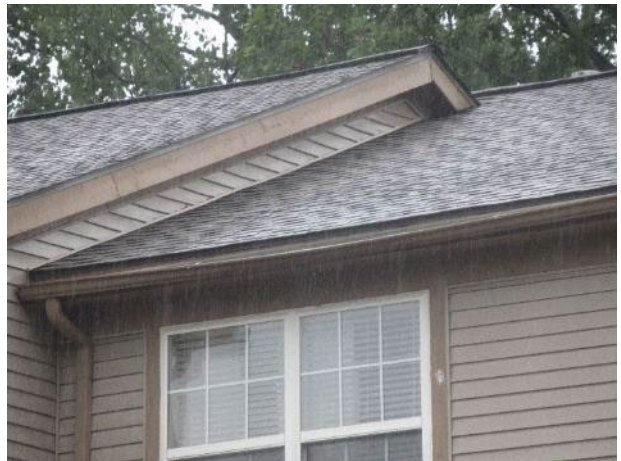
Loose gutter (unit 2792 shown)

Gutter deflection (unit 2825 shown)

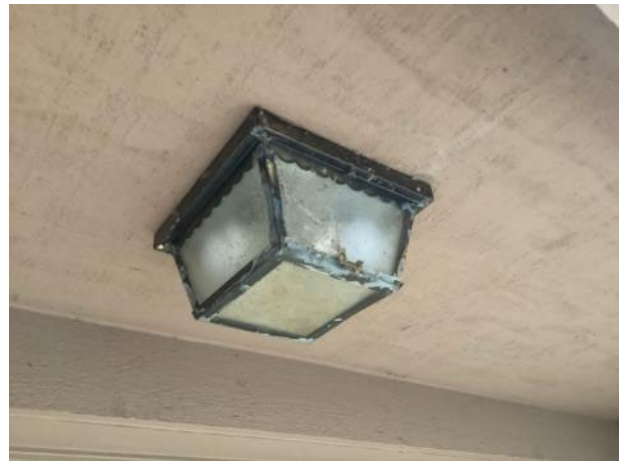
Fixture finish deterioration

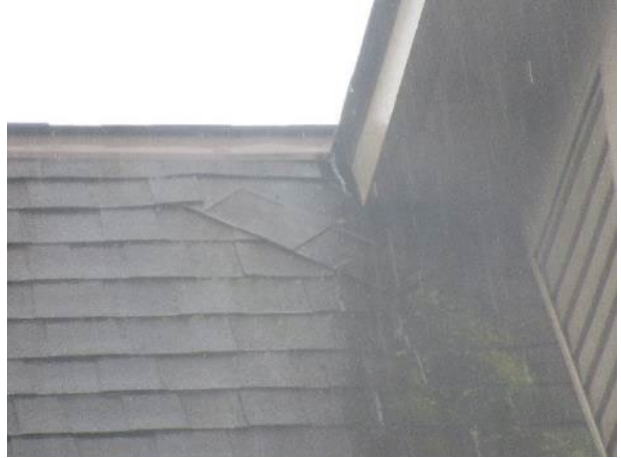
Loose and missing shingles (unit 3030 shown)

Loose shingles and organic growth (unit 3060 shown)

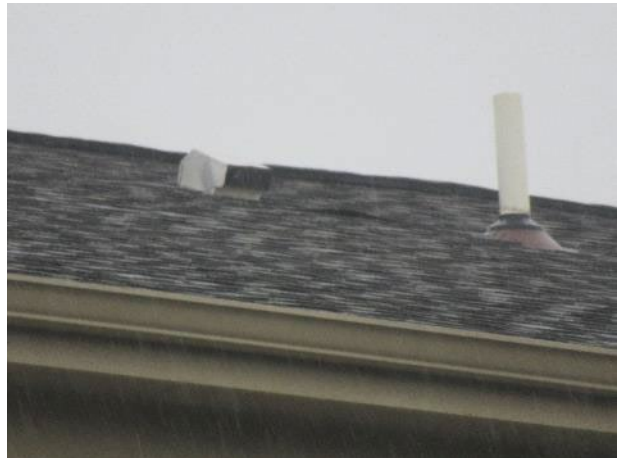
Loose shingles (unit 3047 shown)

Nail pop (unit 2791 shown)

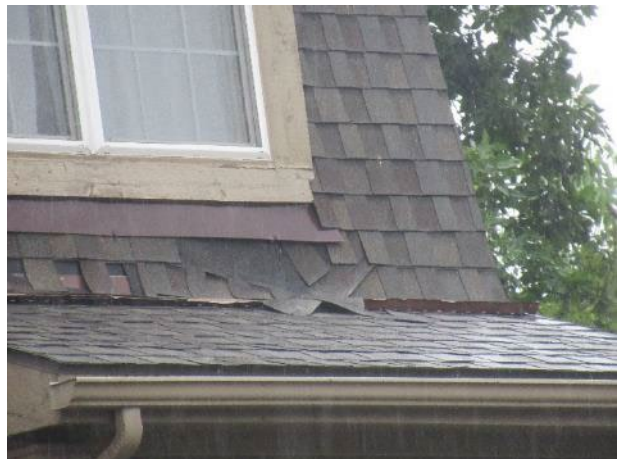
Loose shingles (unit 2767 shown)

Loose shingles (unit 2723 shown)

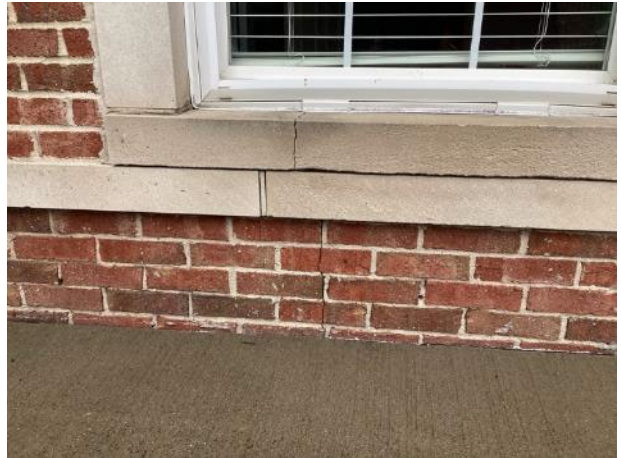
Masonry step cracks (clubhouse shown)

Masonry cracks (clubhouse shown)

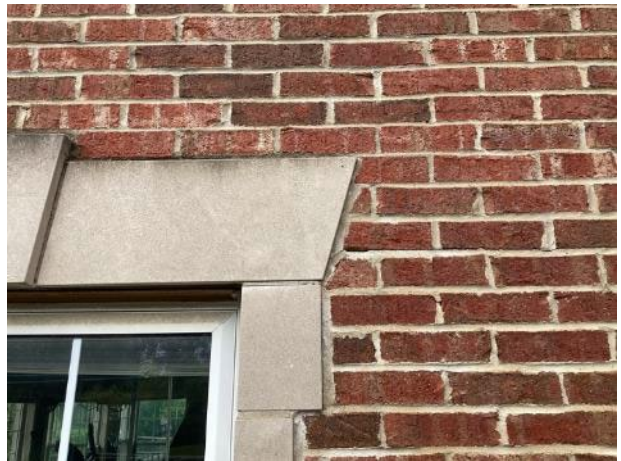
Masonry cracks (clubhouse shown)

Rust jacking (clubhouse shown)

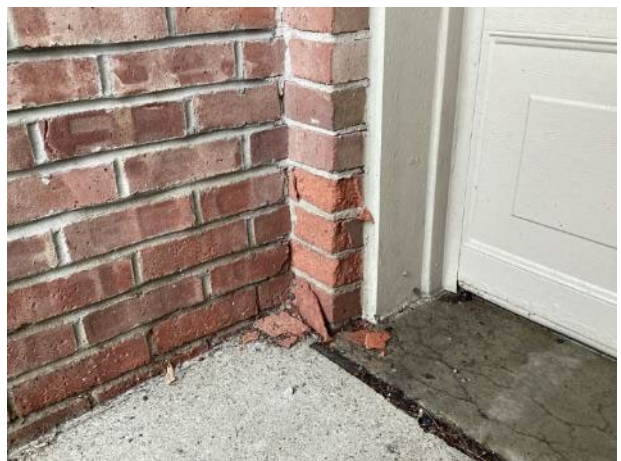
Mortar deterioration

Masonry spall (unit 2768 shown)

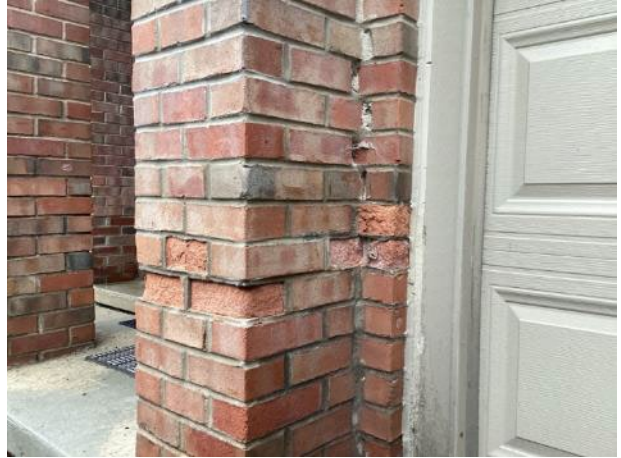
Previous repairs

Masonry spalls and mortar deterioration (unit 2874 shown)

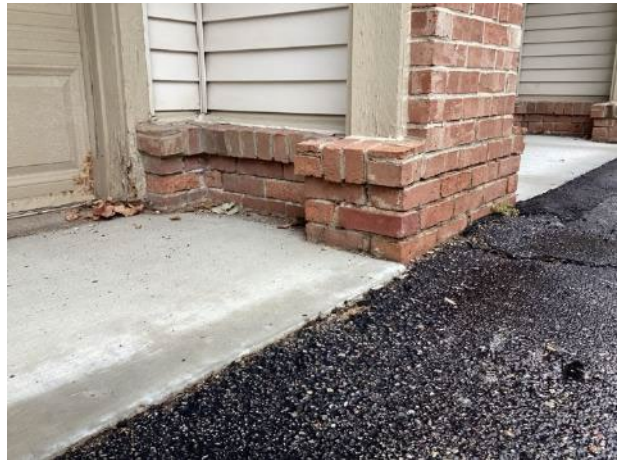
Masonry staining

Mortar deterioration and masonry spalls

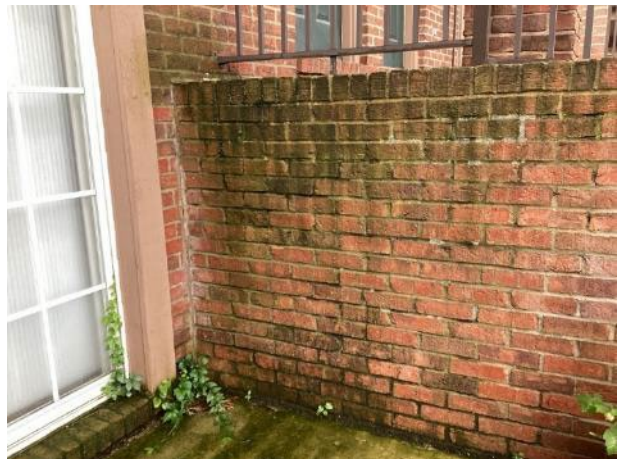
Mortar deterioration and cracks (unit 2798 shown)

Mortar deterioration

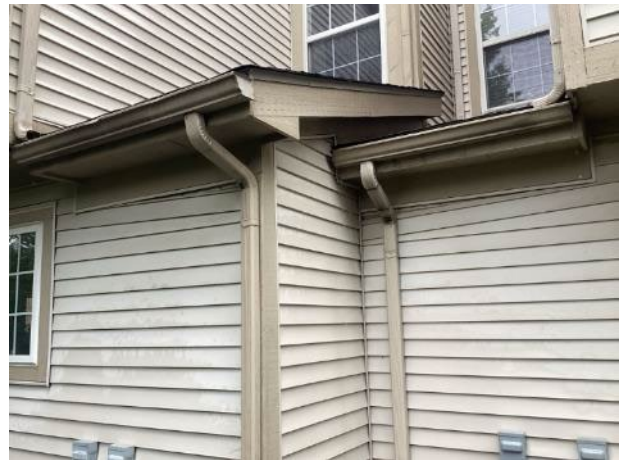
Loose siding (unit 2830 shown)

Loose siding (unit 2866 shown)

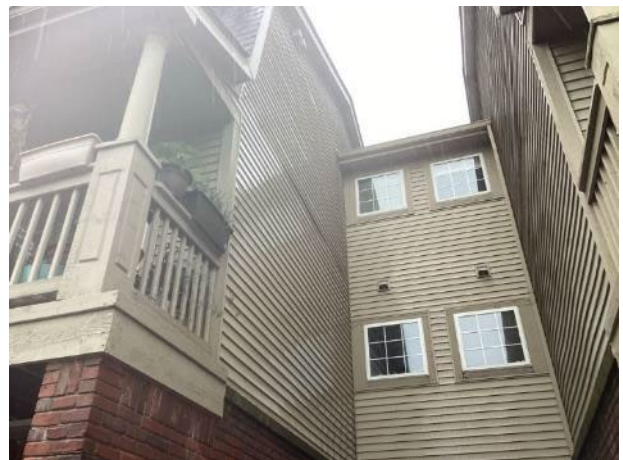
Loose siding (unit 2812 shown)

Loose siding (unit 3053 shown)

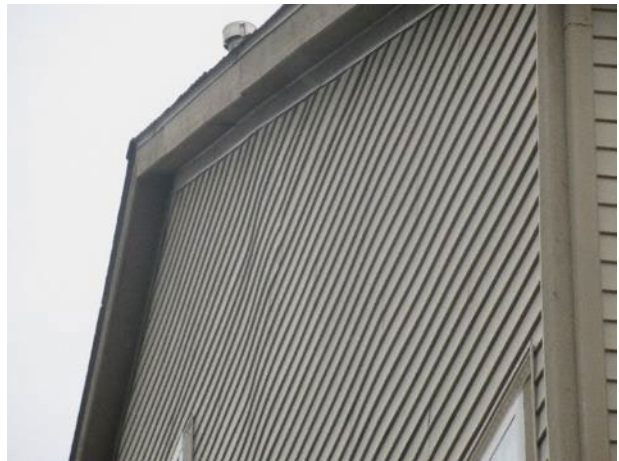
Loose siding (unit 2950 shown)

Warped siding (unit 2950 shown)

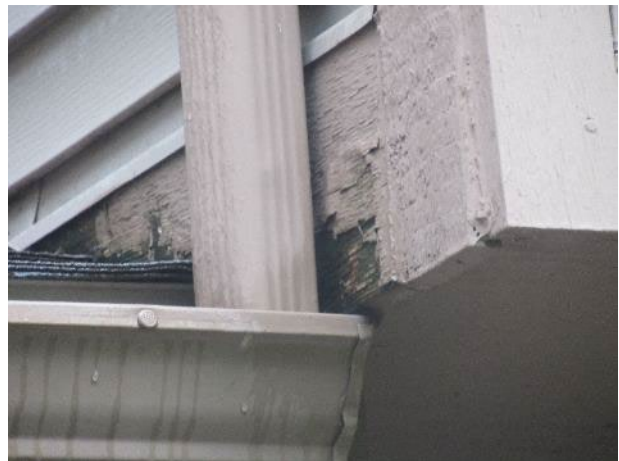
Paint finish deterioration

Trim deterioration

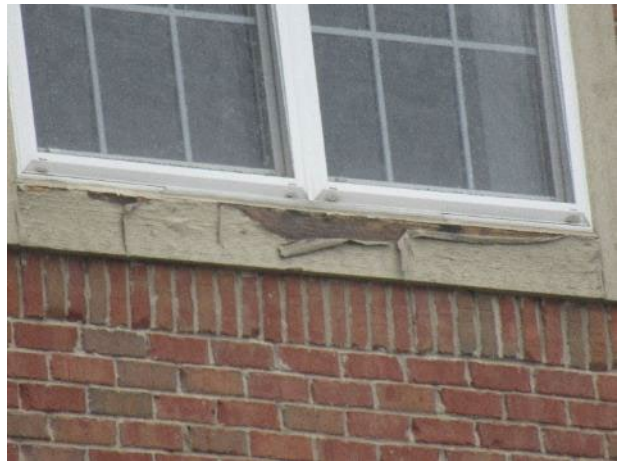
Trim rot

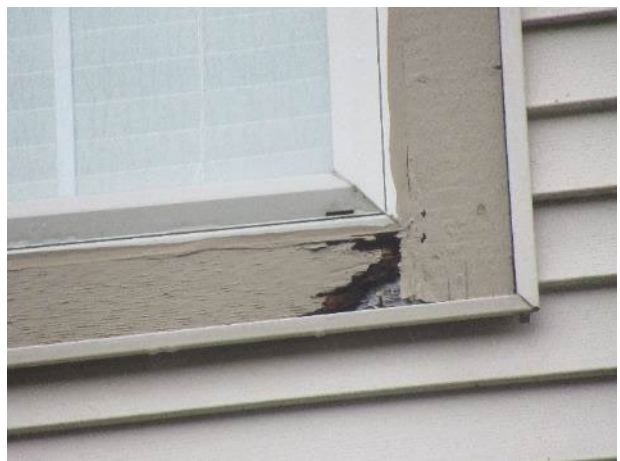
Trim rot

Trim rot (unit 2890 shown)

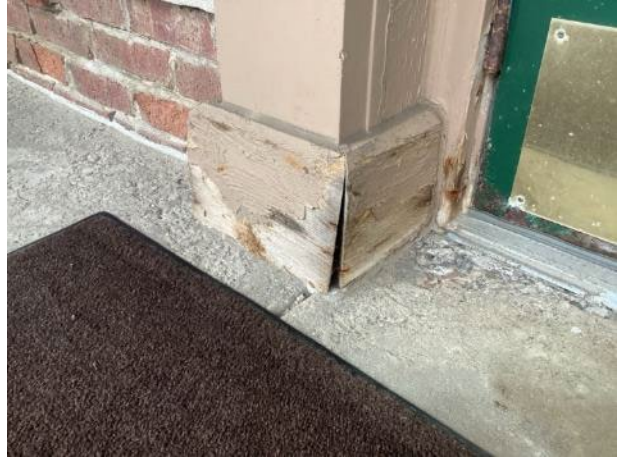
Paint finish deterioration

Trim deterioration (clubhouse shown)

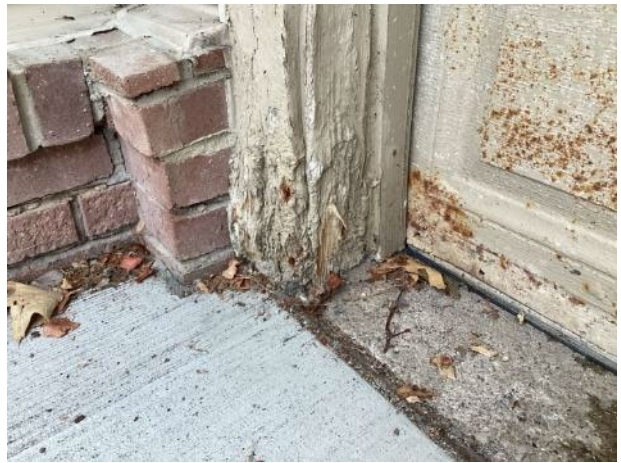
Trim and soffit deterioration

Trim rot

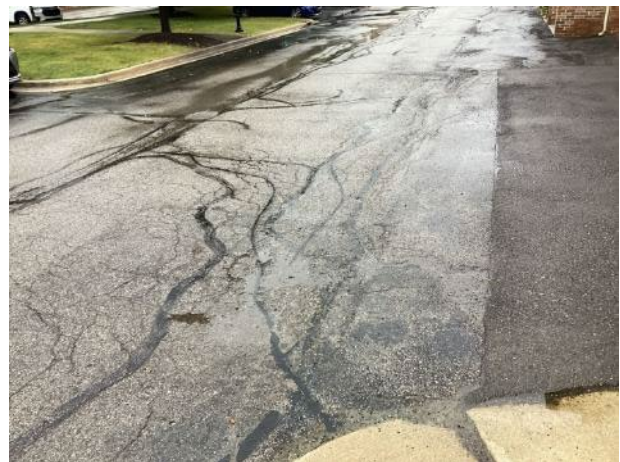
Pavement deterioration

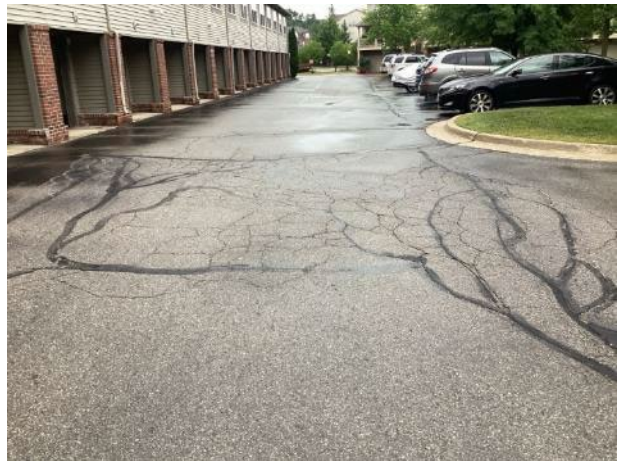
Pavement deterioration

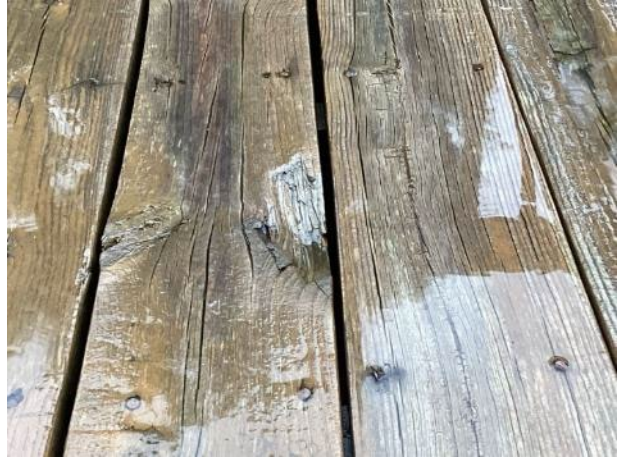
Deck board deflection

Deck board deterioration

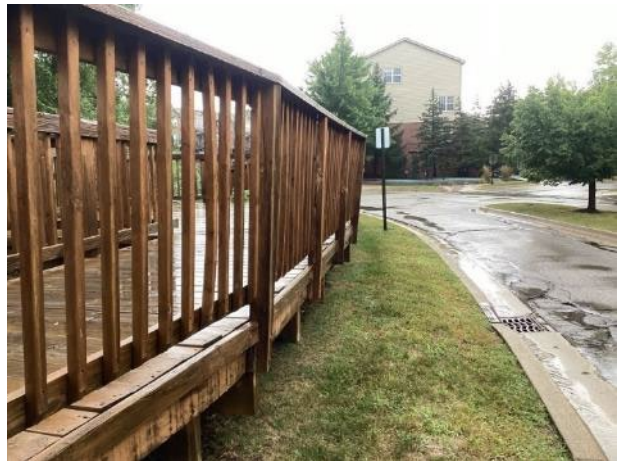
Deck board rot

Railing lean

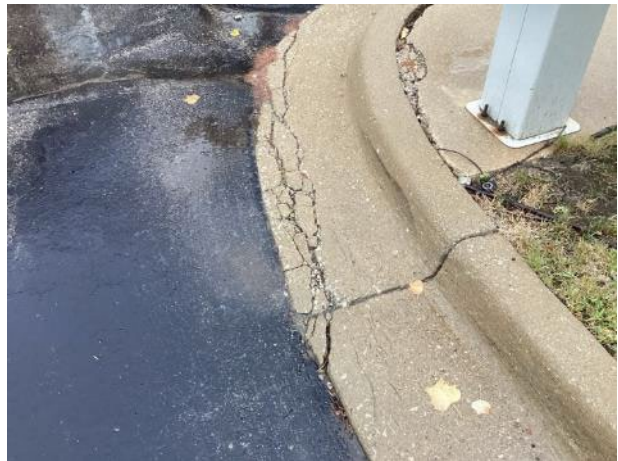
Concrete spalls

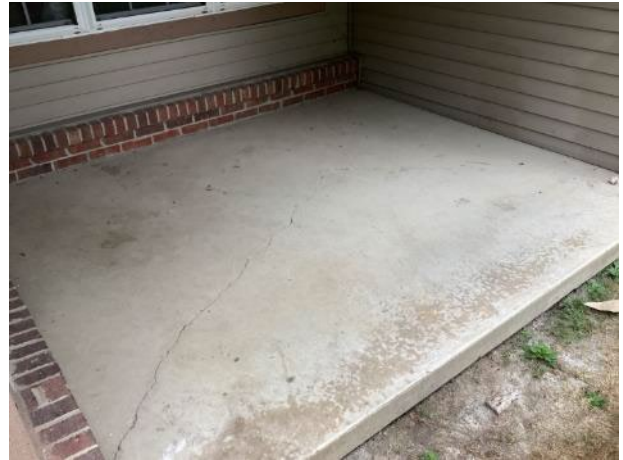
Patio cracks (unit 2804 shown)

Patio cracks

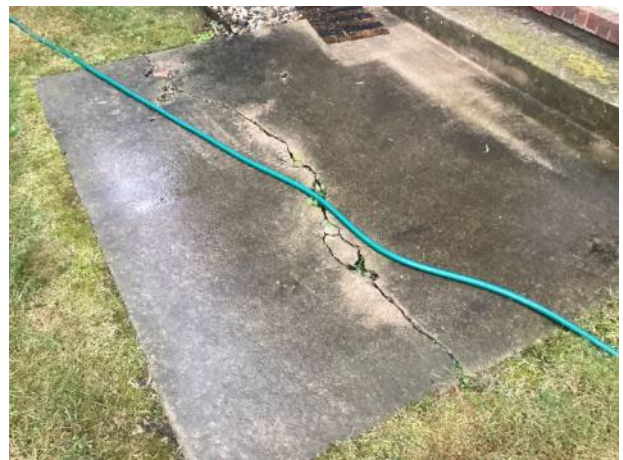
Patio cracks

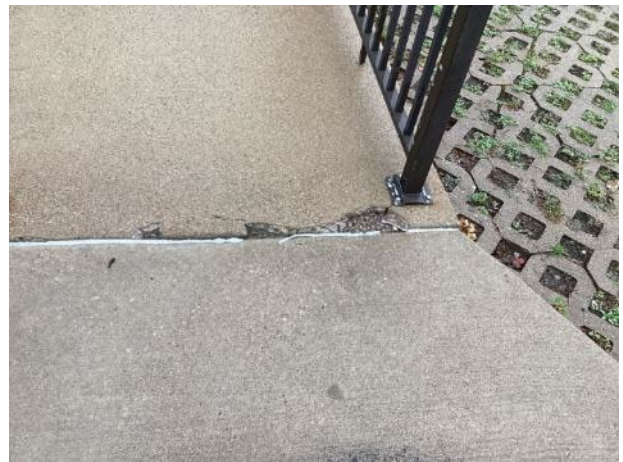
Sidewalk cracks

Sidewalk spalls

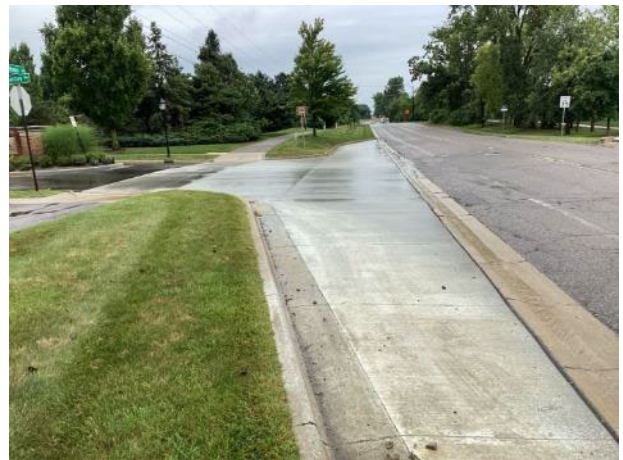
Sidewalk cracks

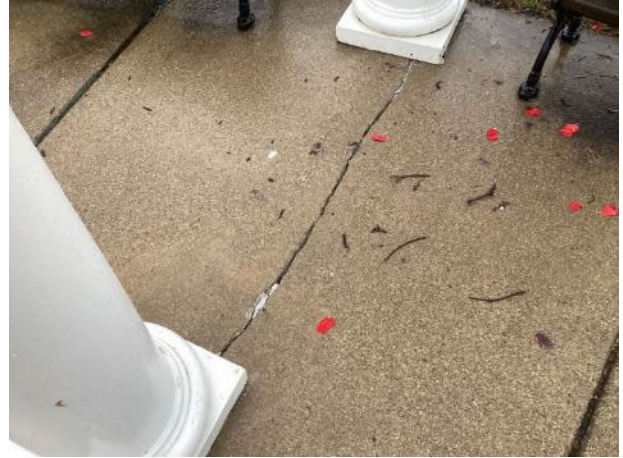
Sidewalk cracks

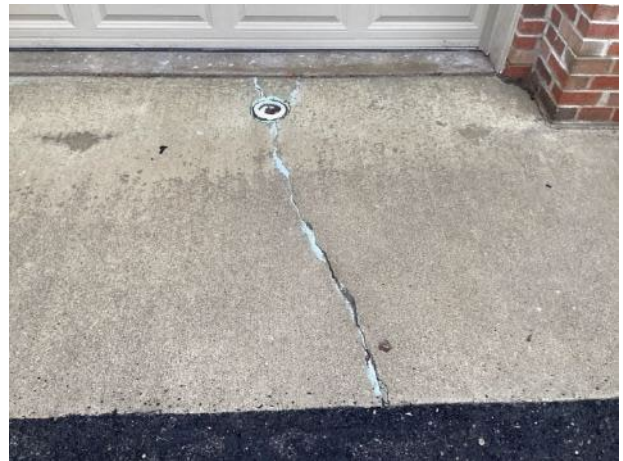
Garage apron cracks

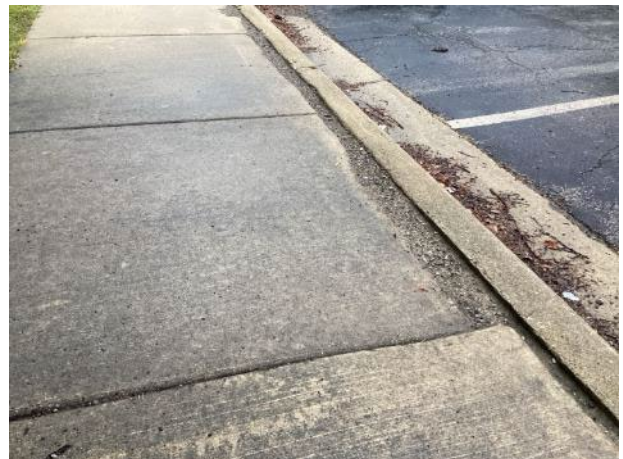
Sidewalk settlement

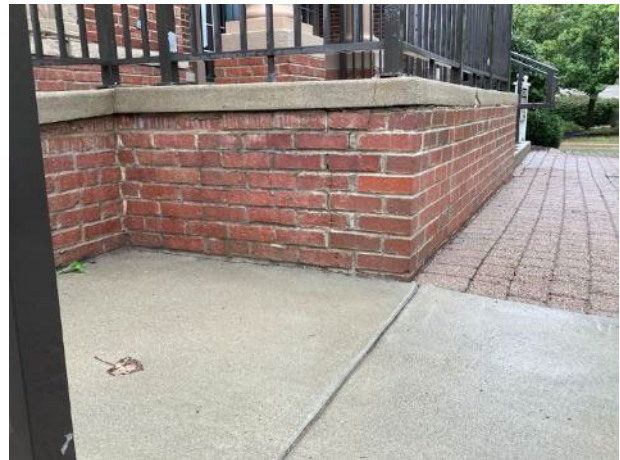
Stoop spall (clubhouse shown)

Stoop cracks (clubhouse shown)

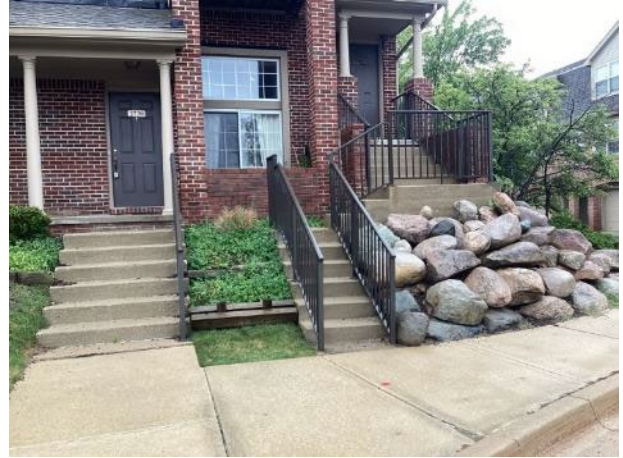
Concrete cracks

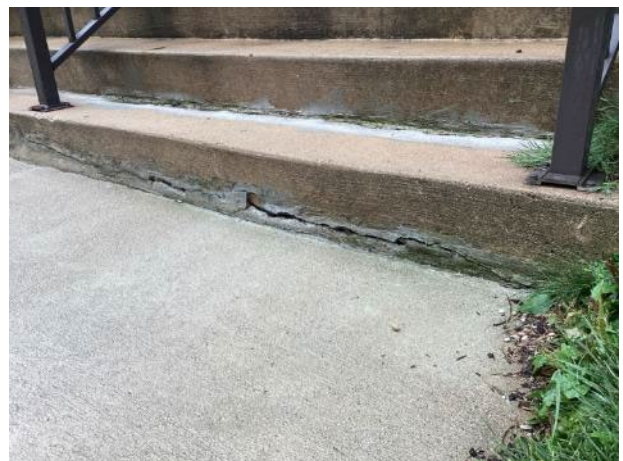
Stair cracks

Stair spalls

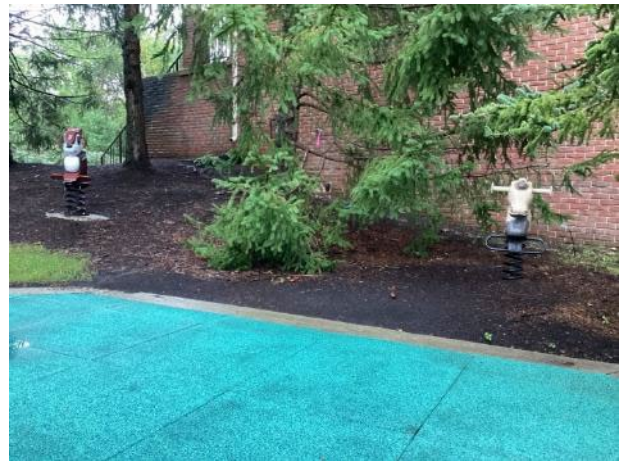
Equipment finish deterioration

Fastener rust

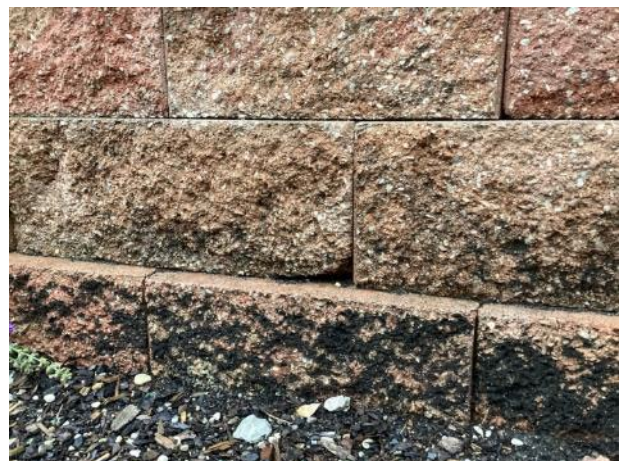
Wall block settlement

Wall block spall

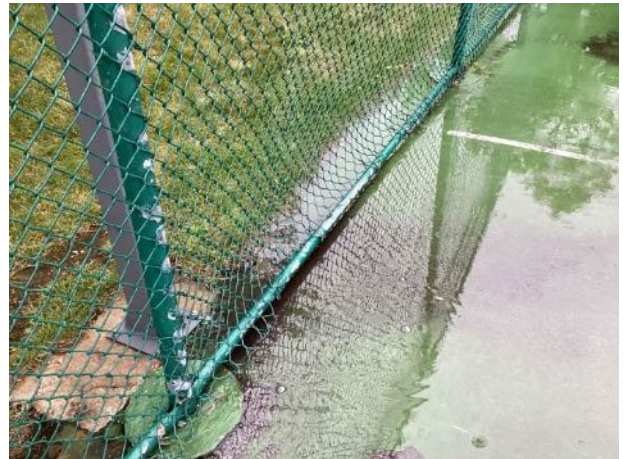
Fence finish deterioration and warped webbing

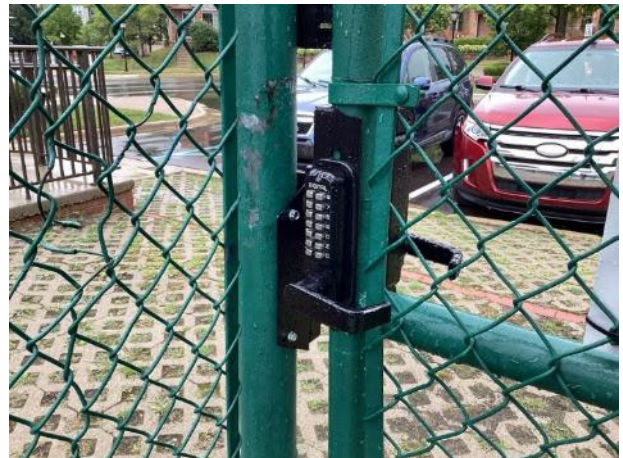
Fence warped webbing

New locks and fence post damage

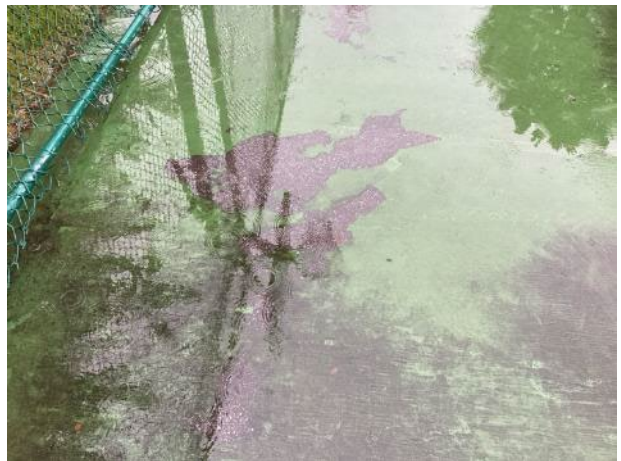
Surface cracks

Color coat fade

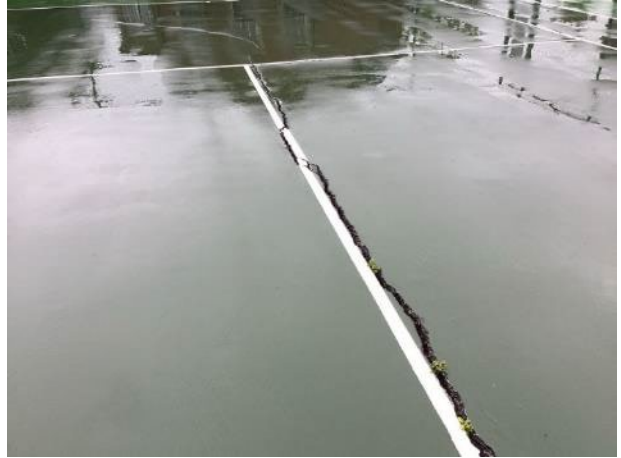
Surface cracks

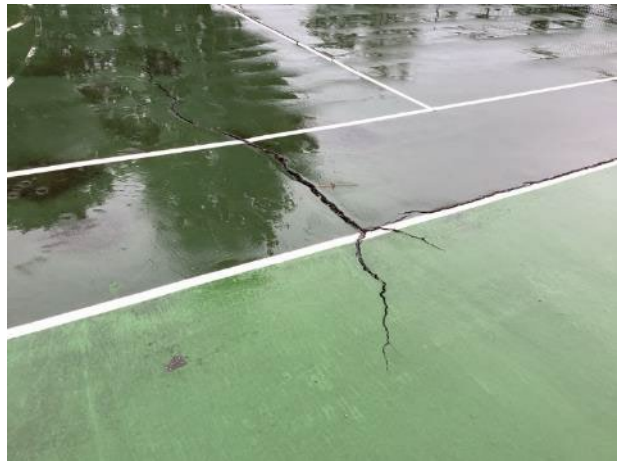
Court settlement and cracks

Surface cracks

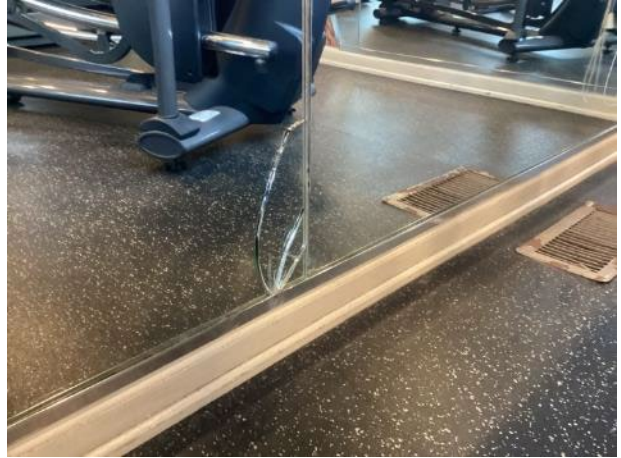
Wall covering damage

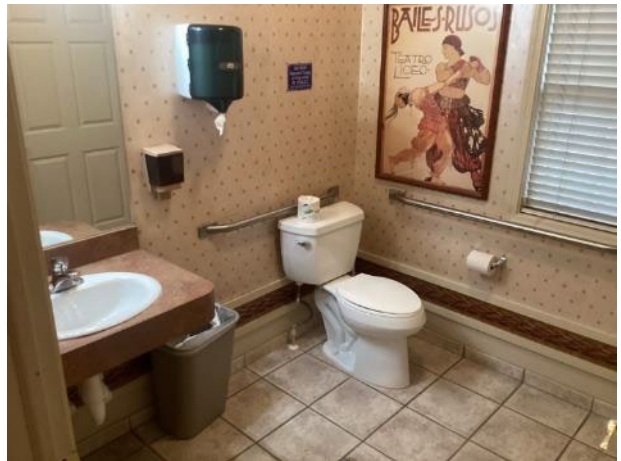
Tile damage

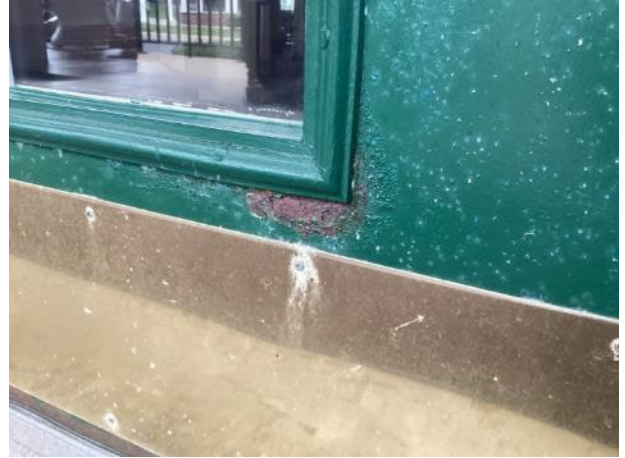
Finish deterioration

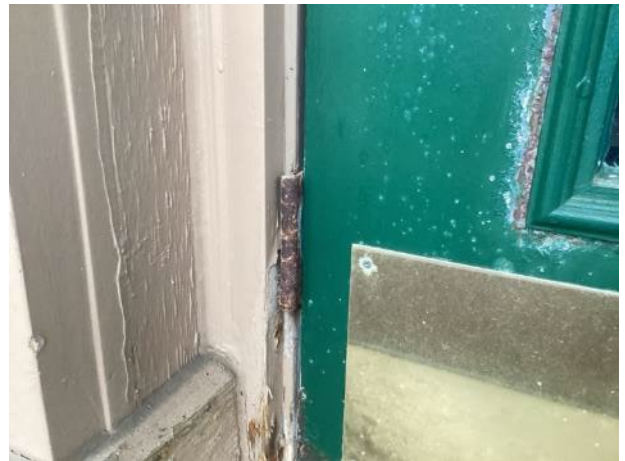
Finish deterioration

Fastener rust

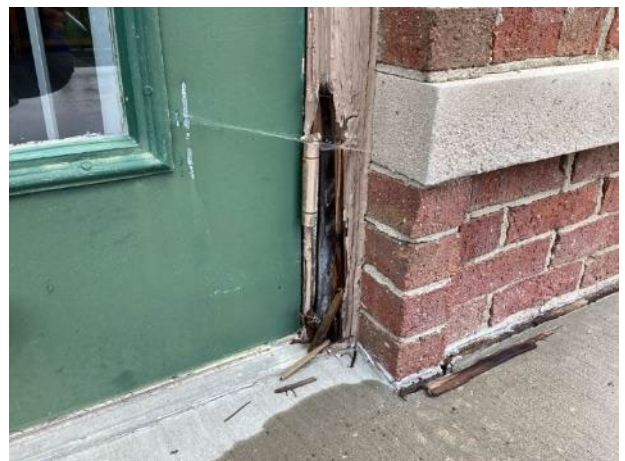
Rear door in need of replacement

Door trim rot
