Barclay Park Condominium

Inspected: August 6, 2024 • Revised on: May 23, 2025
Ann Arbor, MI

RESERVE STUDY

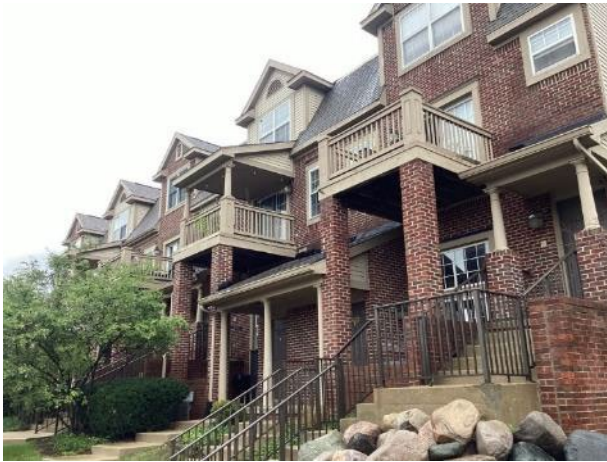
Condition: Fair to poor overall with periodic deflection, wood rot, loose fasteners, fastener rust, warped components and weathered wood evident.

Balcony overview

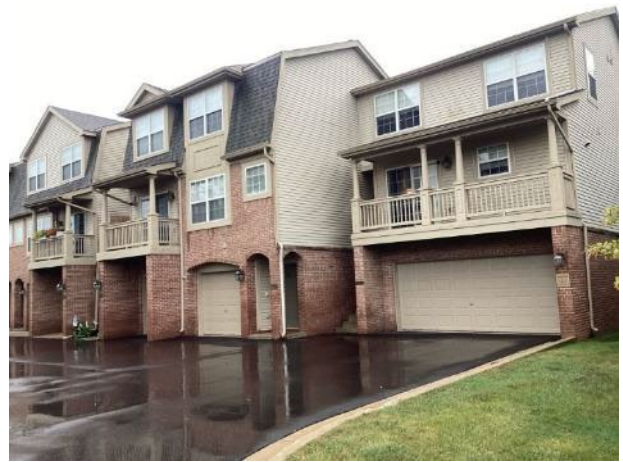
Balcony overview

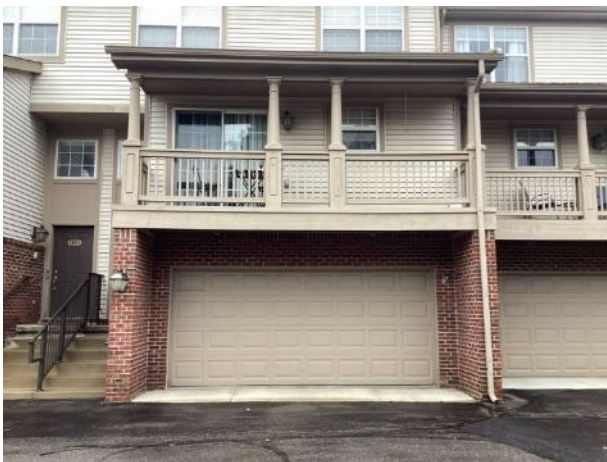
Balcony deflection (unit 2896 shown)

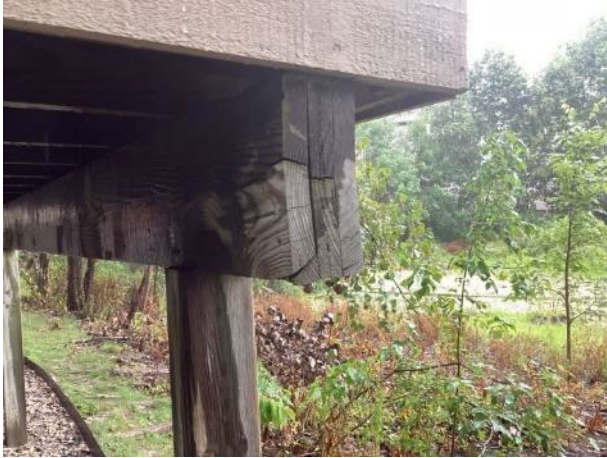
Beam cracks (unit 2968 shown)

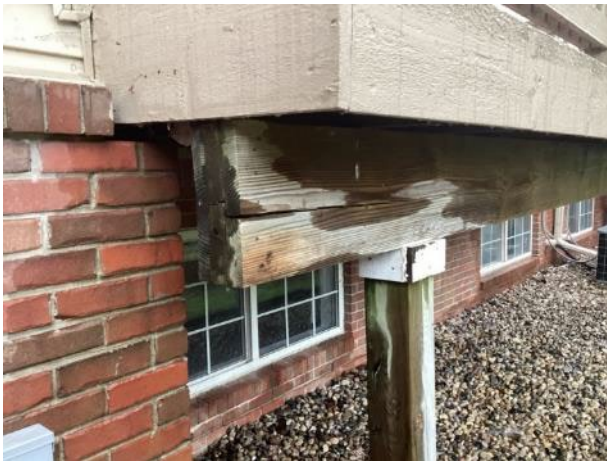
Beam cracks

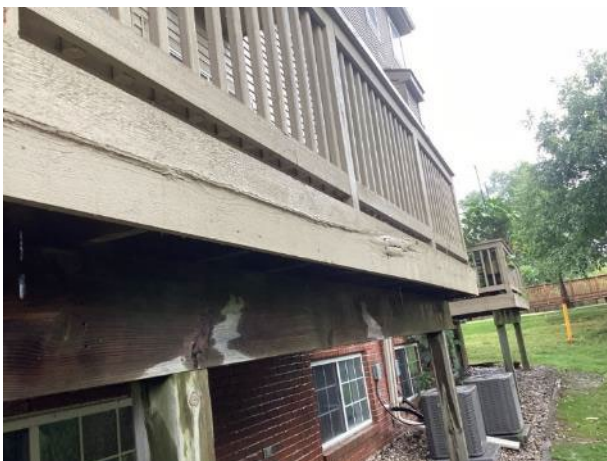
Balcony trim rot

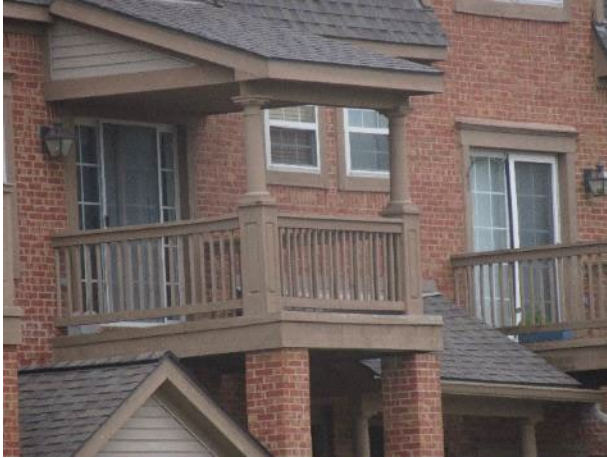
Balcony settlement

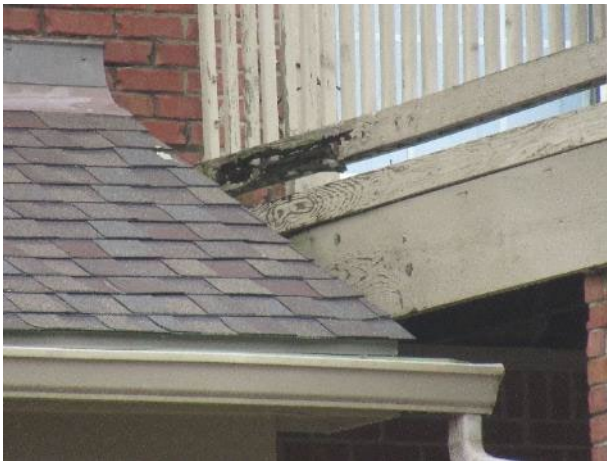
Balcony railing rot (unit 2793 shown)

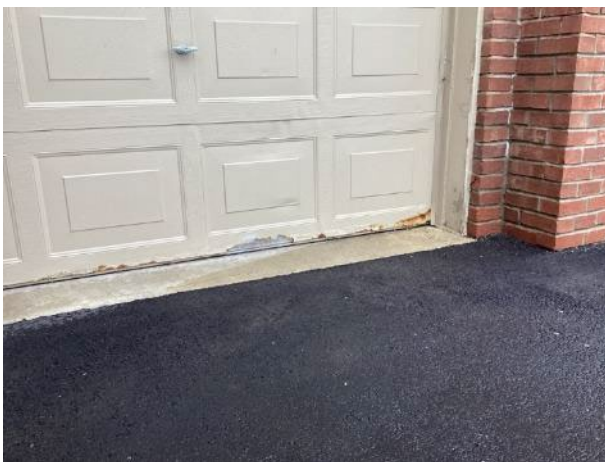
Condition: Fair to poor overall with systemic rust, dents and damage primarily evident at the base panel.

Base panel rust

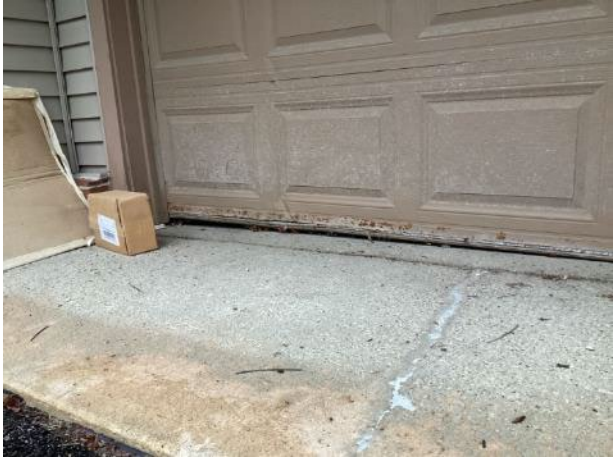
Garage door displacement

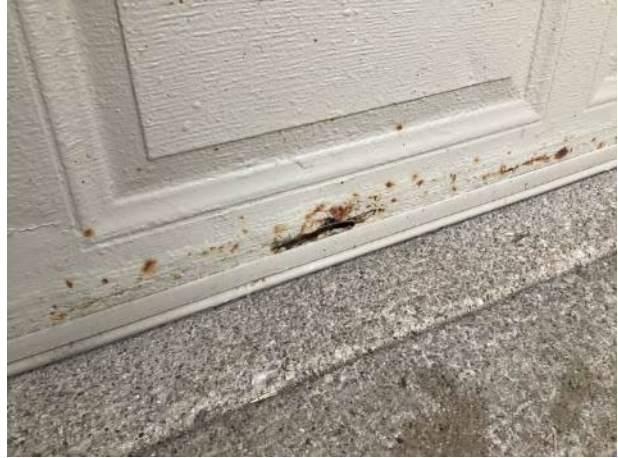
Base panel rust

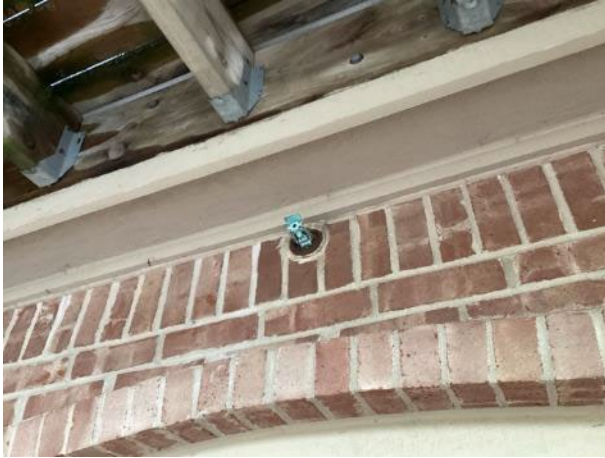
Condition: Fair to poor with aging of devices evident. We also note rust and corrosion at the sprinkler heads.

Corroded sprinkler head

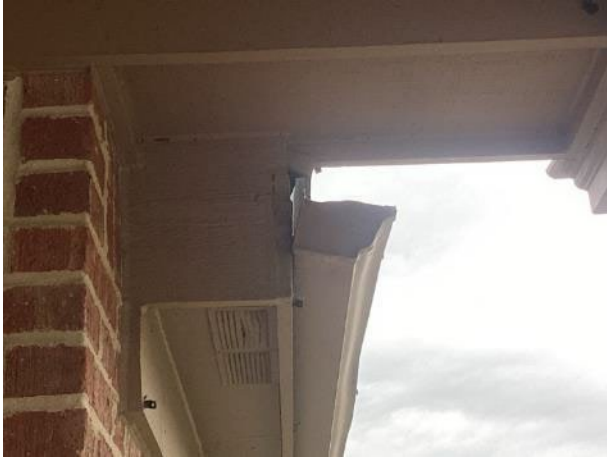
Condition: Fair to poor overall with frequent deflection, fastener rust, leakage at seams, dented sections and missing downspout extensions evident. We defer replacement based on our conversation with Management following our inspection and due to reported maintenance practices. We recommend the Association budget for replacement of the gutters and downspouts in conjunction with the next roof replacements due to interrelated nature of the components. Prior to full replacement in conjunction with the roofs, we recommend the Association adjust their operating budget accordingly to make appropriate repairs and to limit damage to adjacent components such as the trim.

Gutter deflection (clubhouse shown)

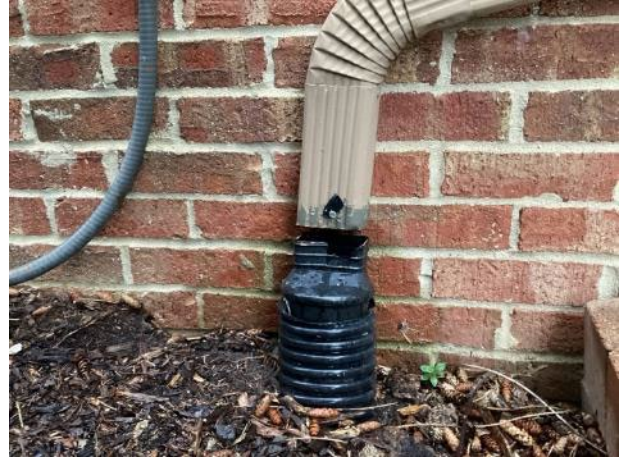
Downspout displacement (clubhouse shown)

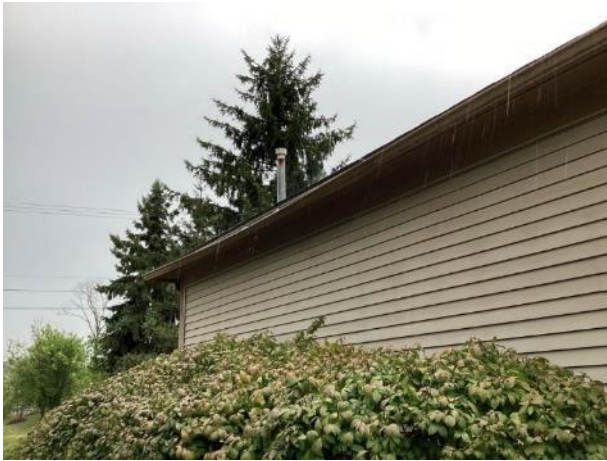
Gutter deflection (garage shown)

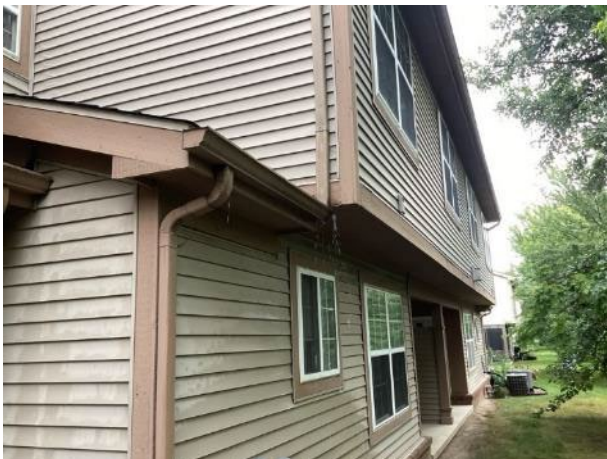
Leakage (unit 2812 shown)

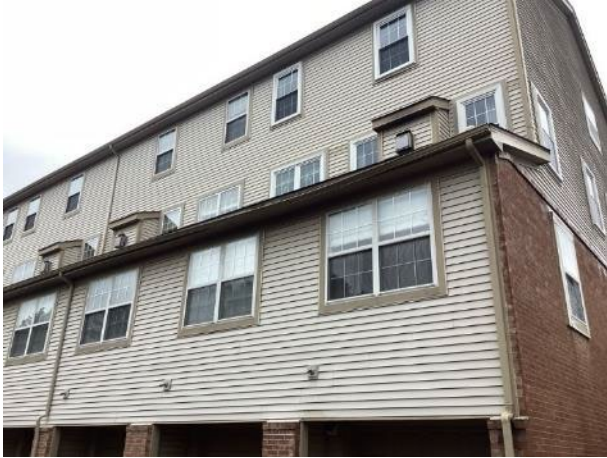
Gutter deflection (unit 2858 shown)

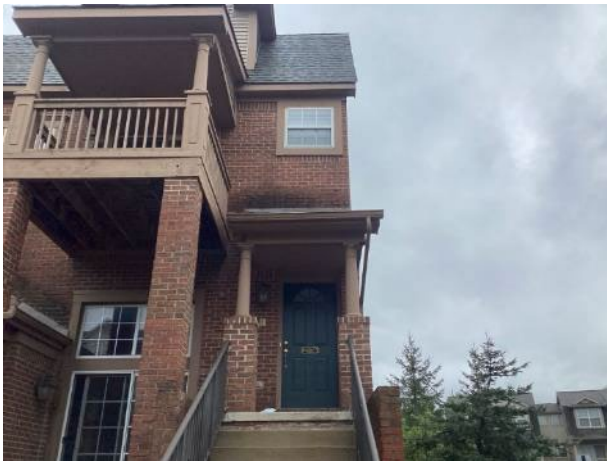
Gutter sloped away from downspout

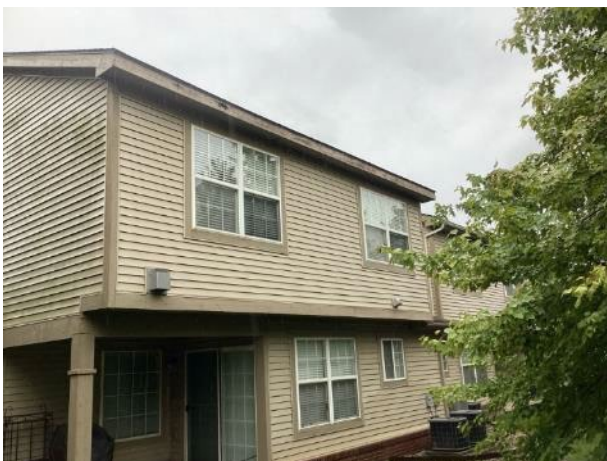
Missing gutter and downspout (unit 2723 shown)

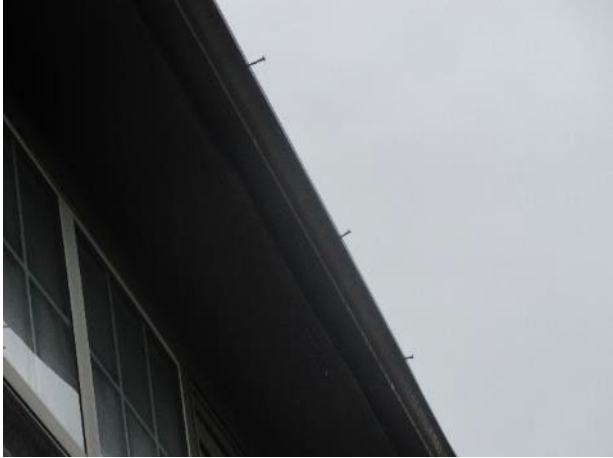
Loose fasteners

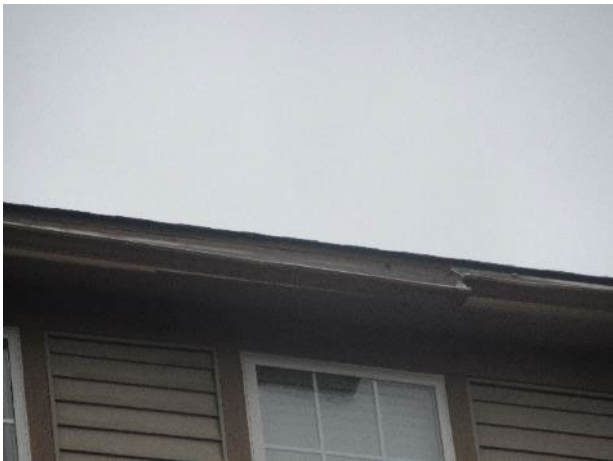
Loose gutter (unit 2792 shown)

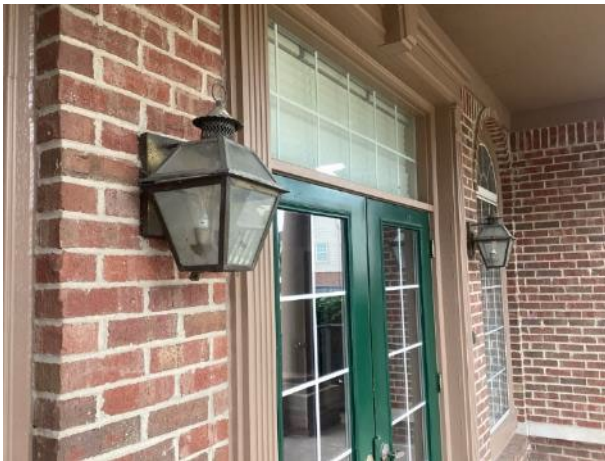
Condition: Poor overall with finish deterioration, loose fixtures and damaged fixtures evident.

Clubhouse light fixtures

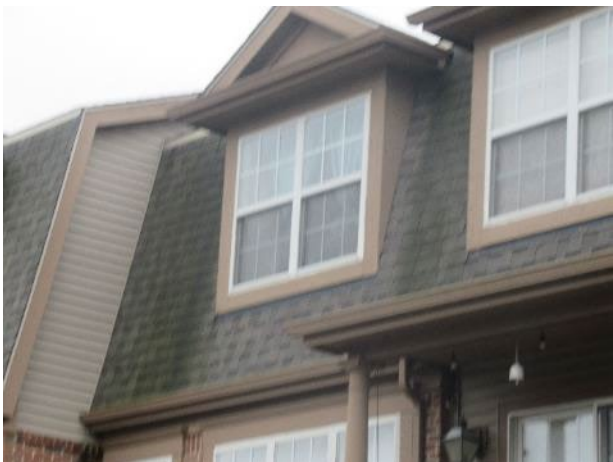
Weathering

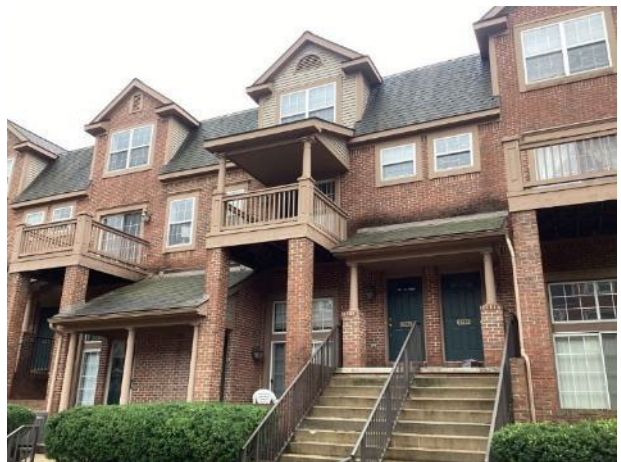
Weathering

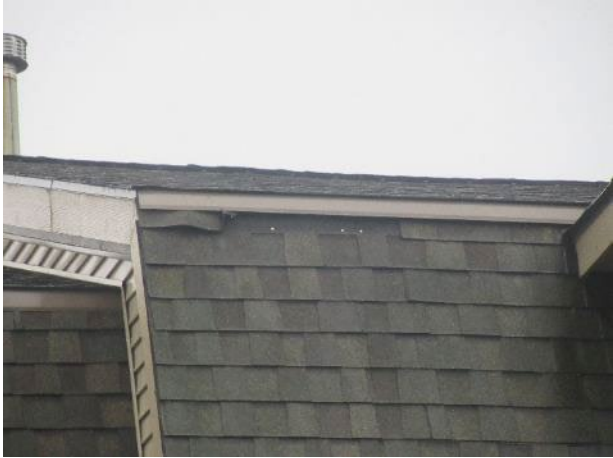
Loose and missing shingles (unit 3030 shown)

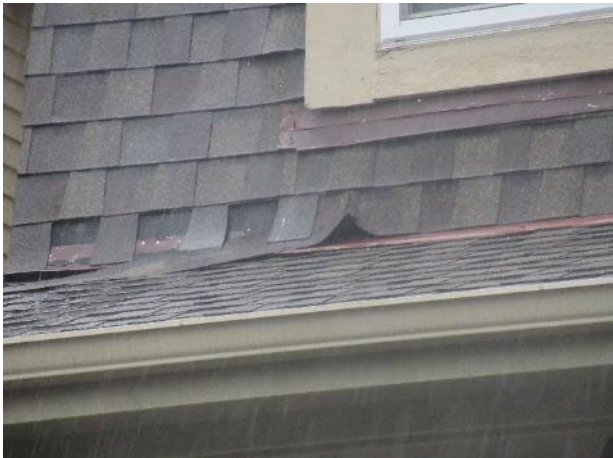
Loose shingles (unit 3047 shown)

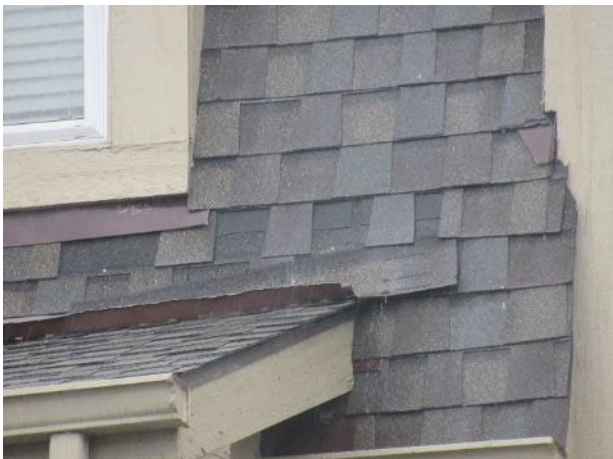
Loose shingles (unit 2767 shown)

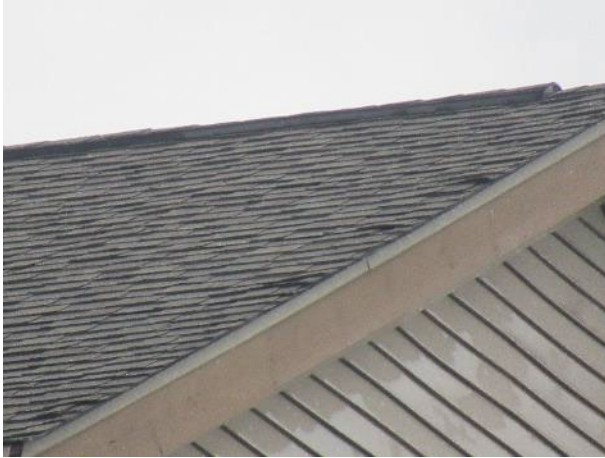
Shingle lift (unit 2865 shown)

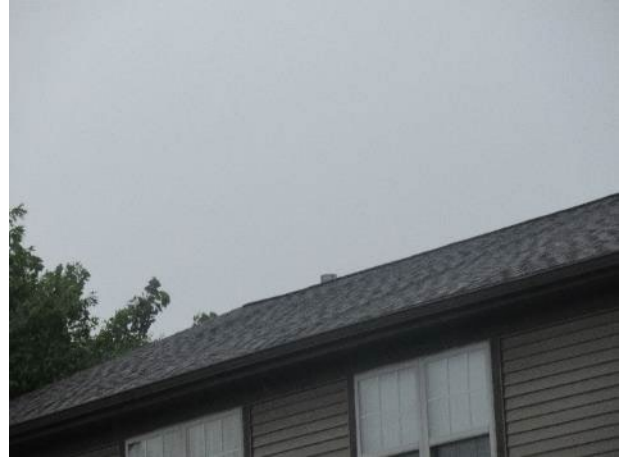
Sheathing deflection

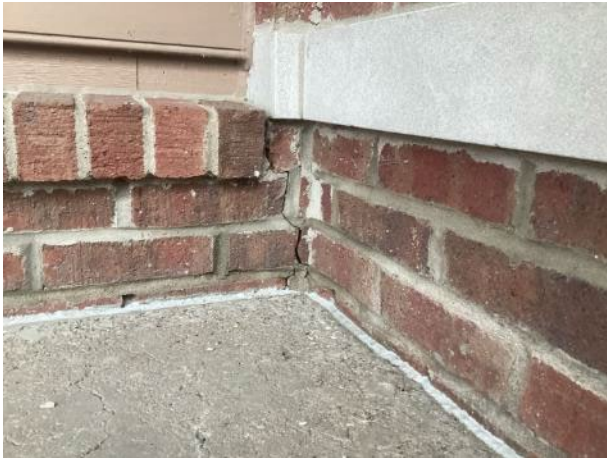
Masonry step cracks (clubhouse shown)

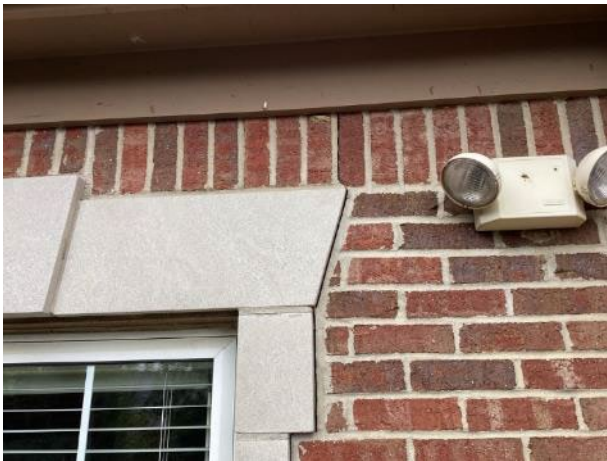
Masonry cracks (clubhouse shown)

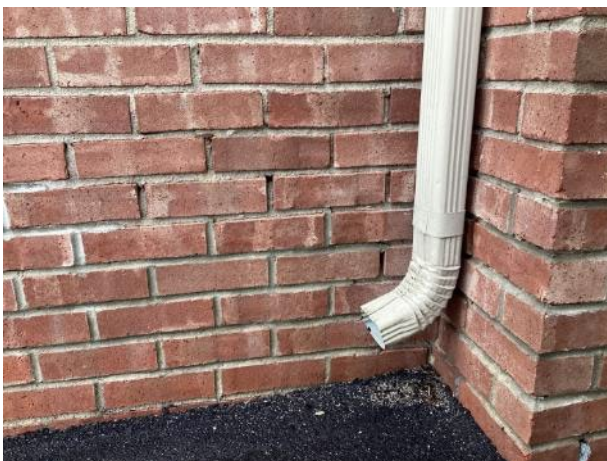
Mortar deterioration

Repointing is a process of raking and cutting out defective mortar to a depth of not less than $\frac{1}{2}$ inch nor more than $\frac{3}{4}$ inch and replacing it with new mortar. Face grouting is the process of placing mortar over top of the existing mortar. We advise against face grouting because the existing, often deteriorated mortar does not provide a solid base for the new mortar. New mortar spalls at face grouted areas will likely occur. One purpose of a mortar joint is to protect the masonry by relieving stresses within the wall caused by expansion, contraction, moisture migration and settlement. Repointed mortar joints are more effective if the mortar is softer and more permeable than the masonry units, and no harder or less permeable than the existing mortar. The masonry contractor should address these issues within the proposed scope of work.

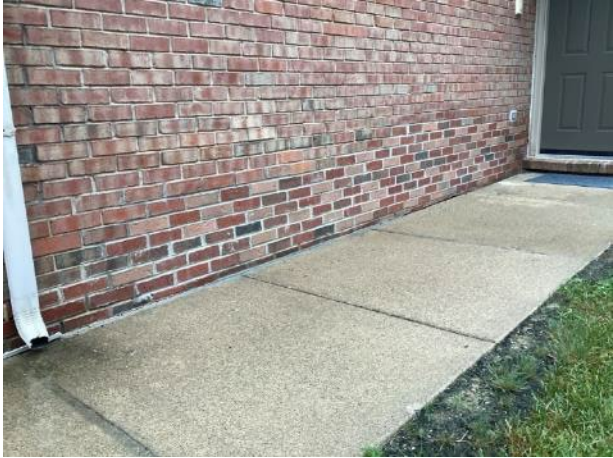
Previous repairs

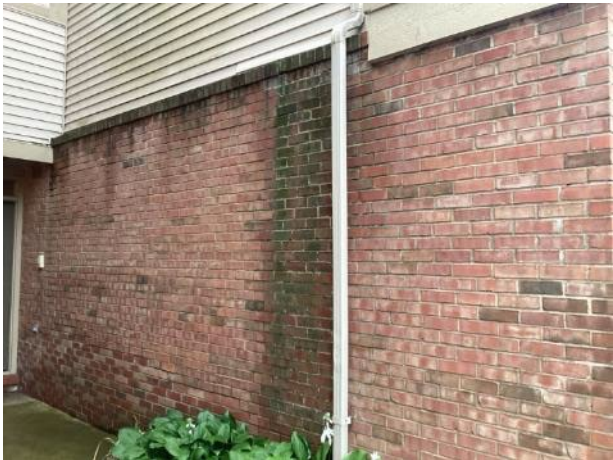
Masonry staining

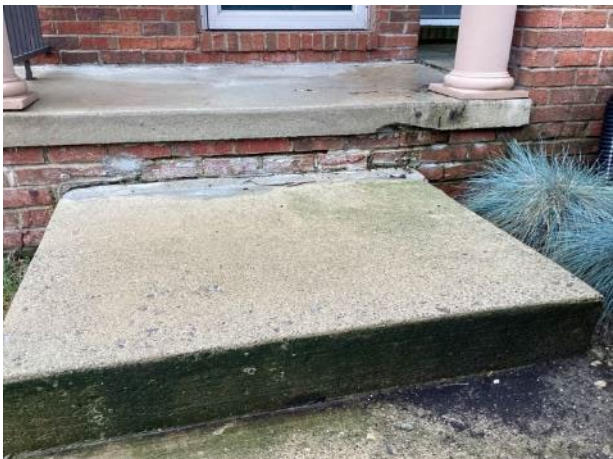
Mortar deterioration and cracks (unit 2798 shown)

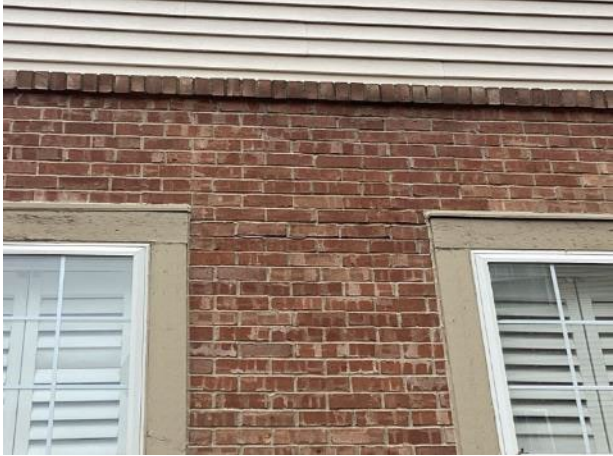
Masonry cracks (unit 2830 shown)

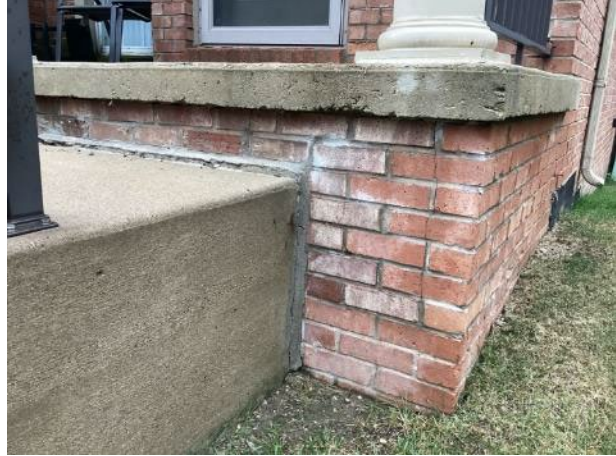
Efflorescence

Component Detail Notes: Common types of masonry deterioration include efflorescence, spalling, joint deterioration and cracking. The primary cause of efflorescence, cracks and face spall is water infiltration; therefore, prevention of water infiltration is the principal concern for the maintenance of masonry applications.

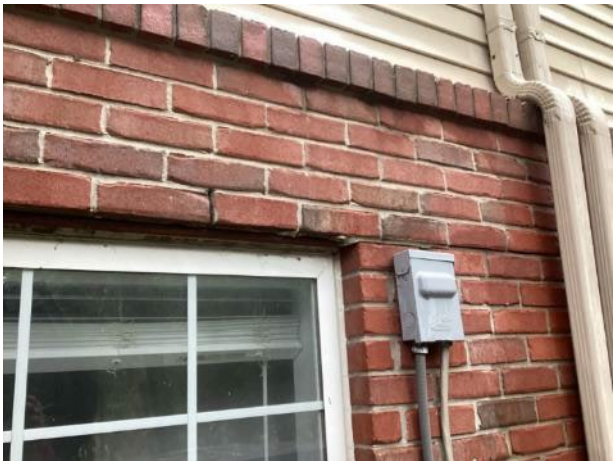
Rust jacking

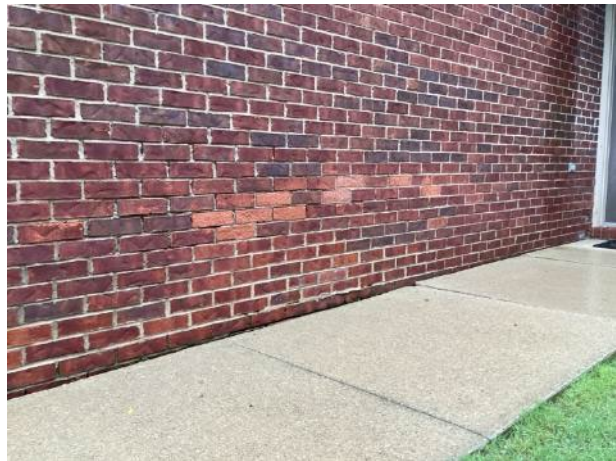
Masonry deterioration (unit 2723 shown)

- Complete inspection of the masonry
- Repointing of the masonry as needed
- Replacement of a limited amount of the masonry (The exact amount of area in need of replacement will be discretionary based on the actual future conditions and the desired appearance.)
- Replacement of sealants as needed

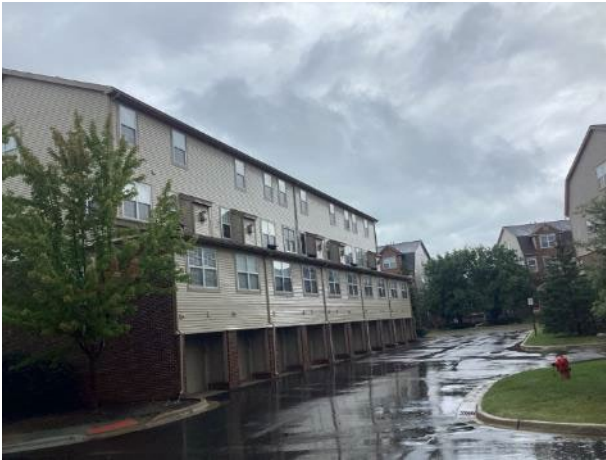
Condition: Fair overall with warps, bulges, loose sections and damage evident. We anticipate the desire for full replacement of the vinyl siding due to increasing difficulty in color matching partial replacements as further repairs are made in the future.

Vinyl siding overview

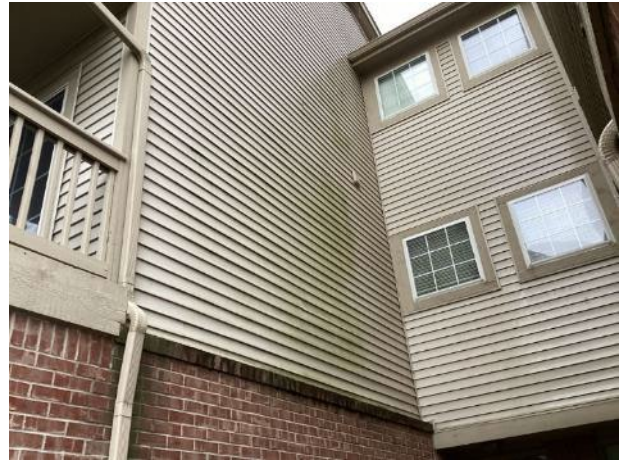
Organic growth

- Annually:
 - Inspect and repair loose siding, warping or damage from wind driven objects or lawn care equipment
 - Periodically clean siding as necessary at areas of organic growth. A non-abrasive household cleaner or manufacturer specified

vinyl siding cleaner will remove more intense stains. We do not recommend pressure cleaning at vinyl siding due to the siding's brittle nature.

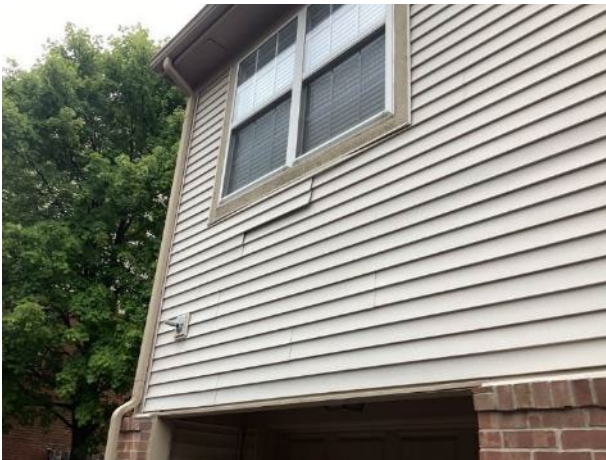
Loose siding (unit 2830 shown)

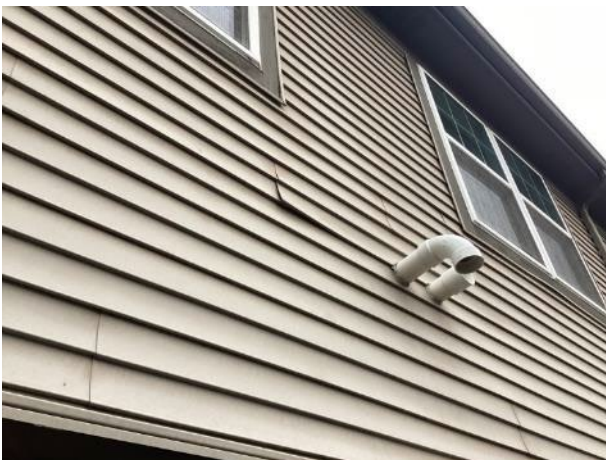
Loose siding (unit 2812 shown)

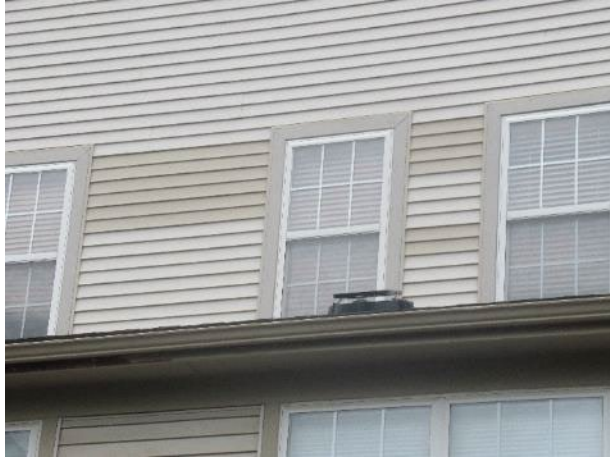
Mis-matched siding

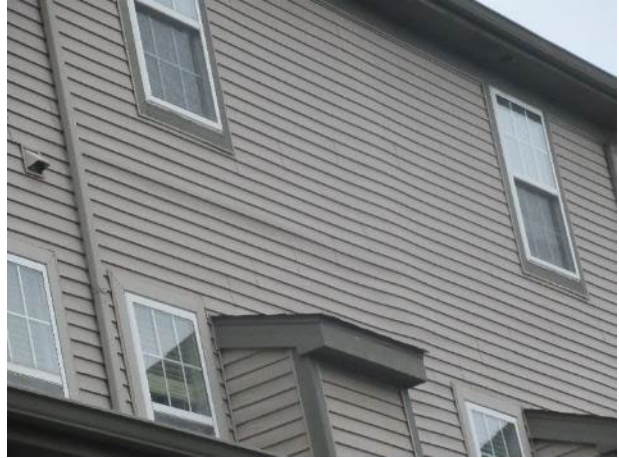
Siding bulge (unit 2922 shown)

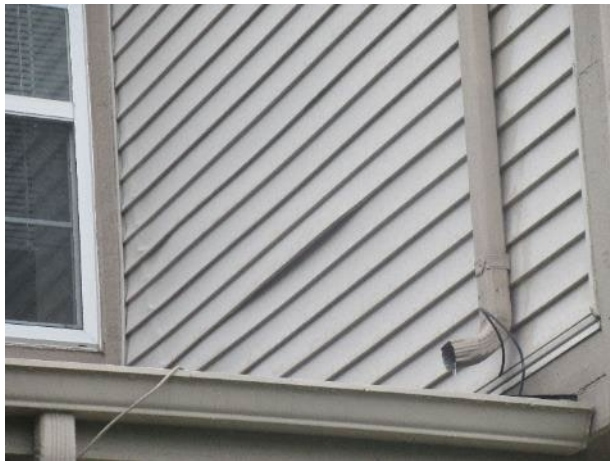
Loose siding (unit 2950 shown)

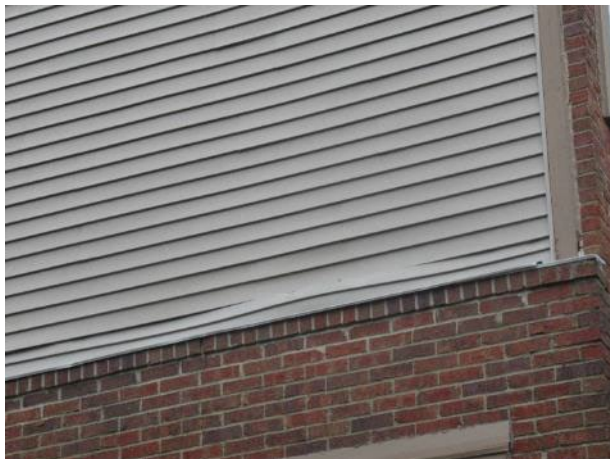
Loose siding (unit 2798 shown)

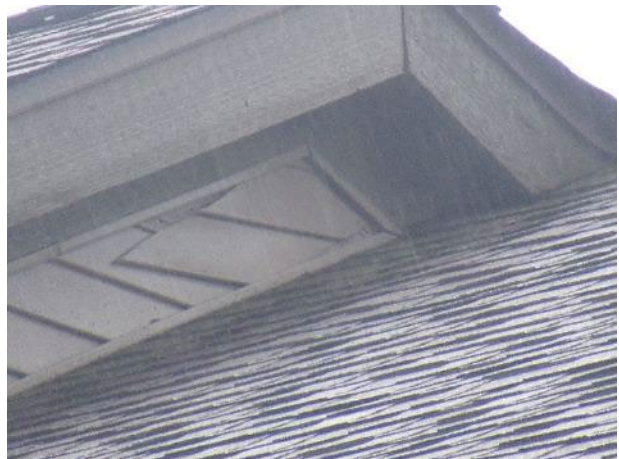
Loose siding (unit 2982 shown)

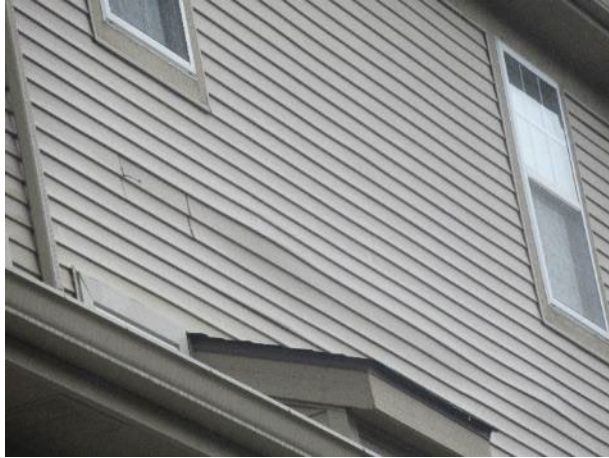
Siding bulge (unit 3008 shown)

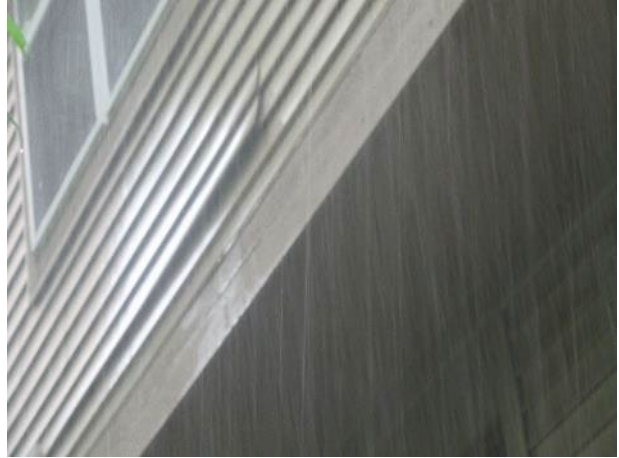
Loose siding (unit 3020 shown)

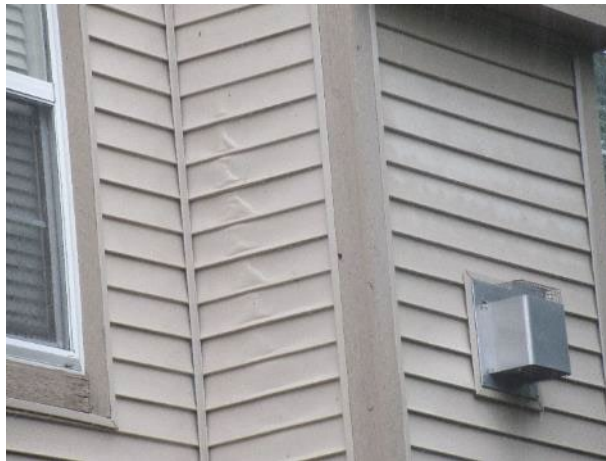
Siding warp (unit 2837 shown)

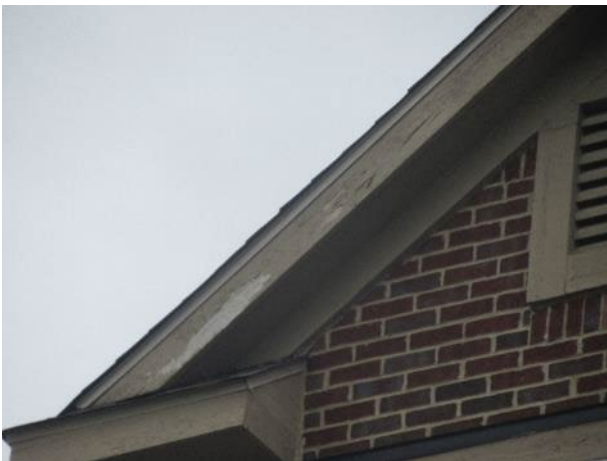
Paint finish deterioration

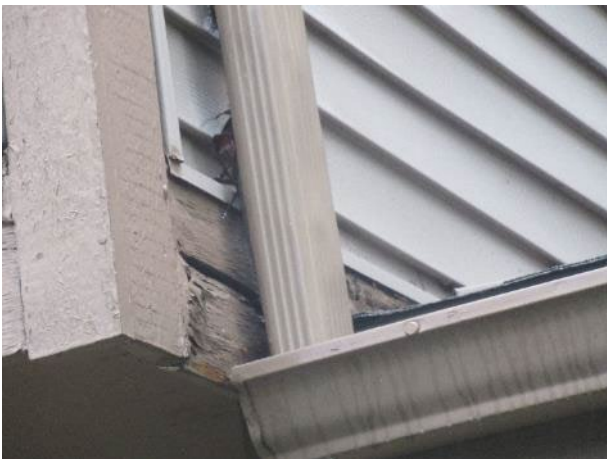
Trim deterioration

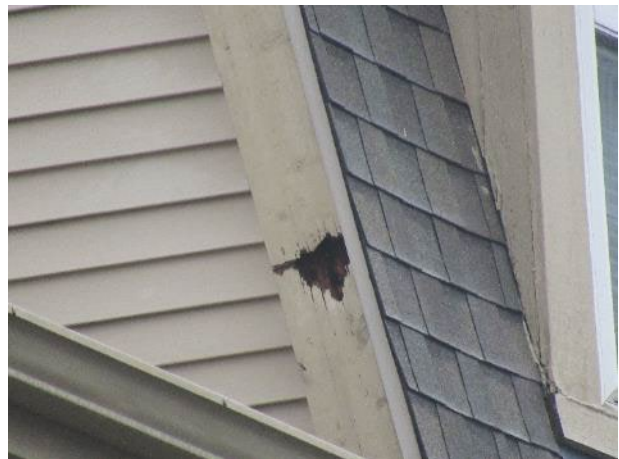
Trim deterioration

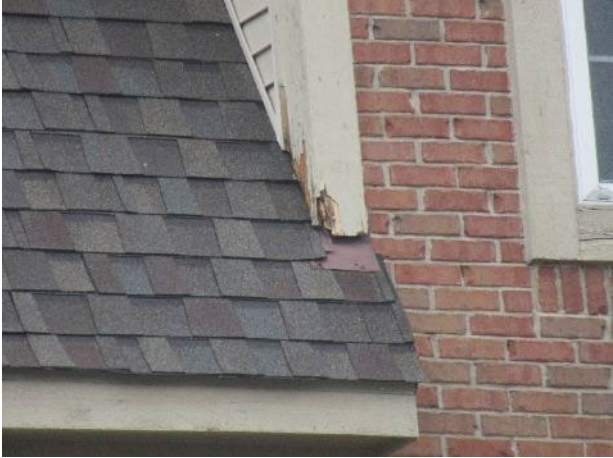
Trim deterioration

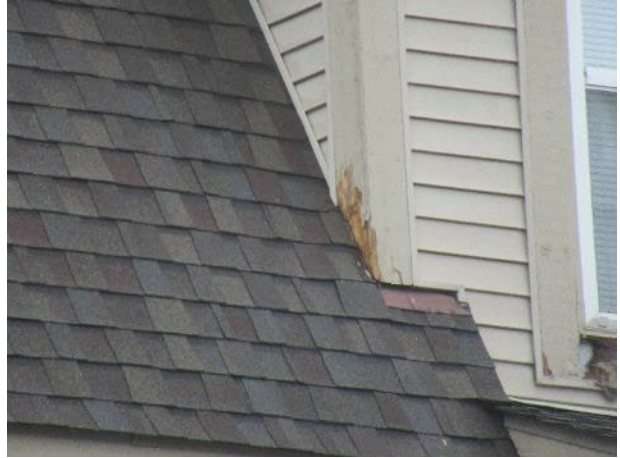
Trim deterioration

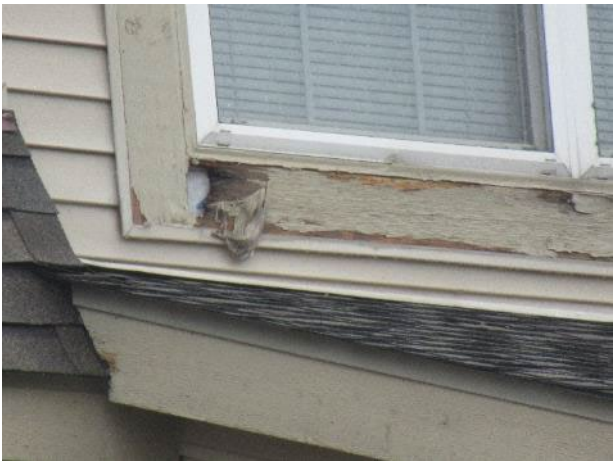
Trim rot

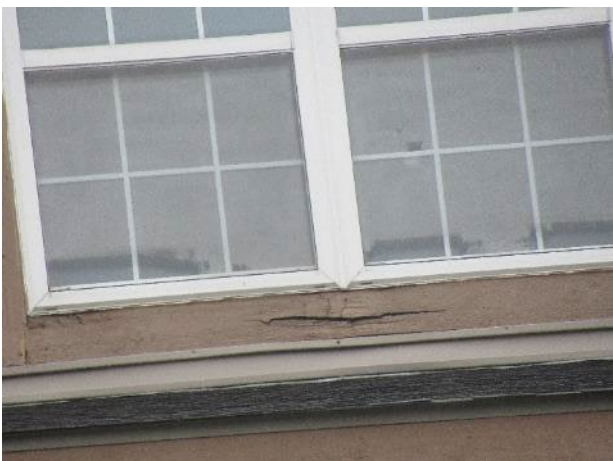
Trim rot

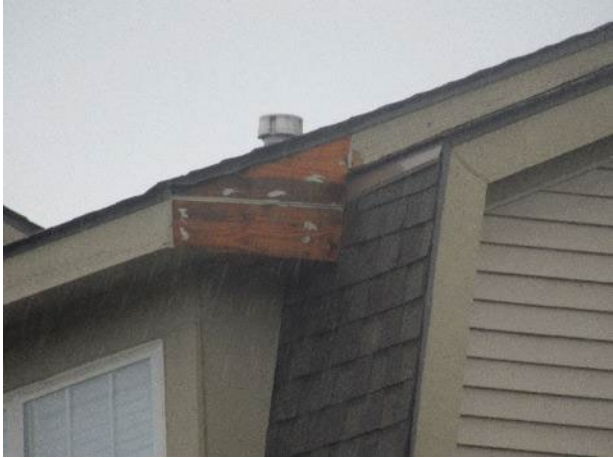
Paint finish deterioration

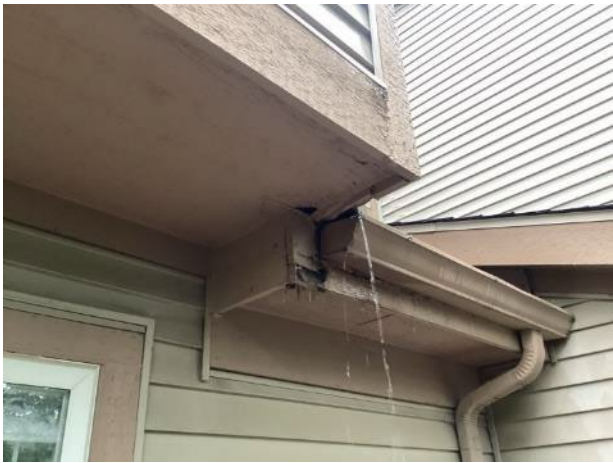
Trim and soffit deterioration

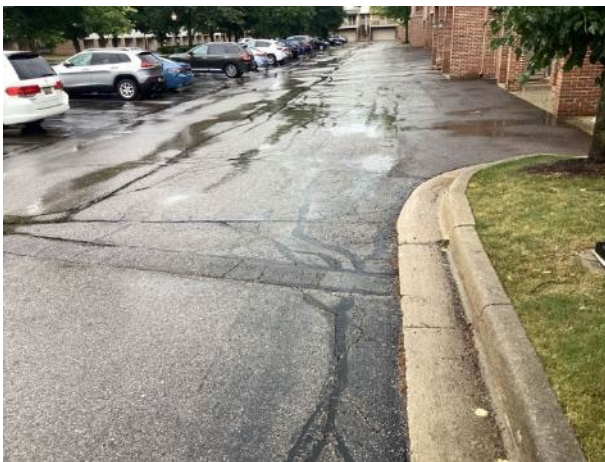
Pavement deterioration

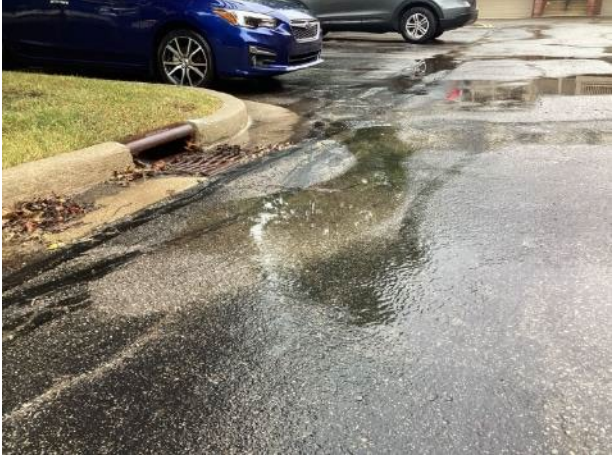
Upheaval near catch basin

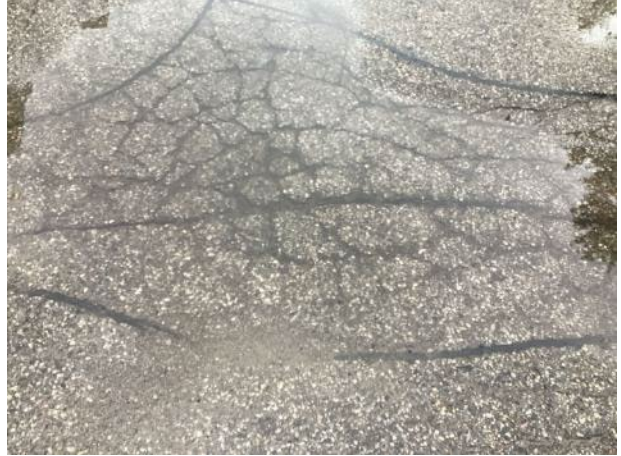
Alligator cracks

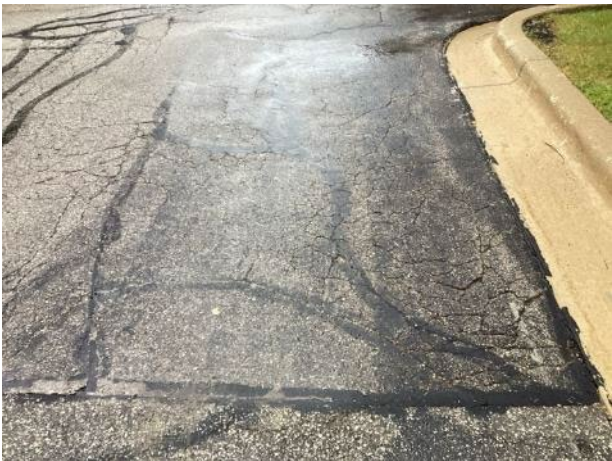
Pavement deterioration

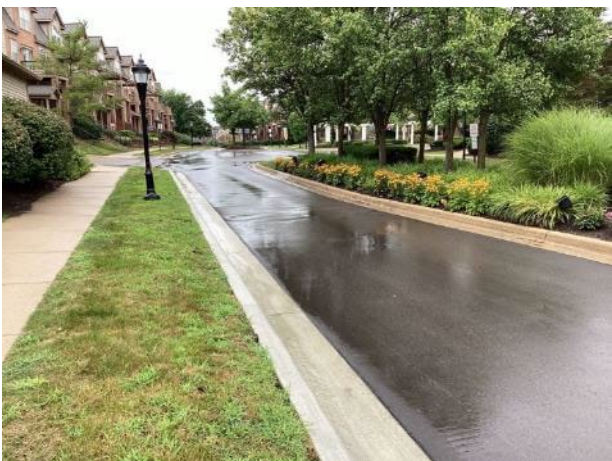
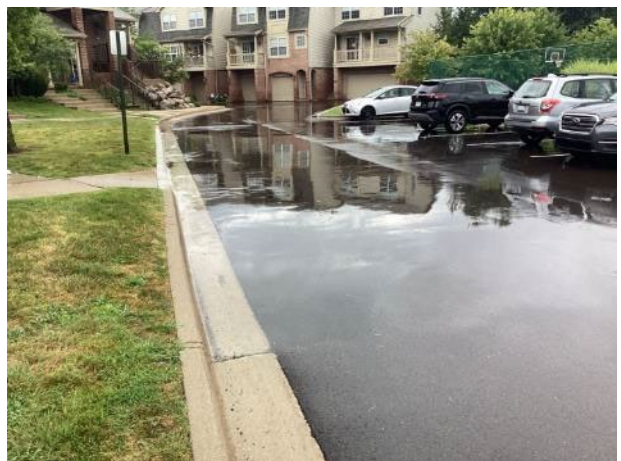
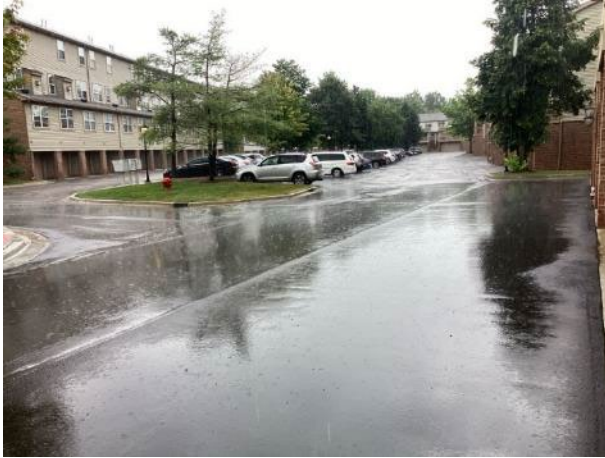
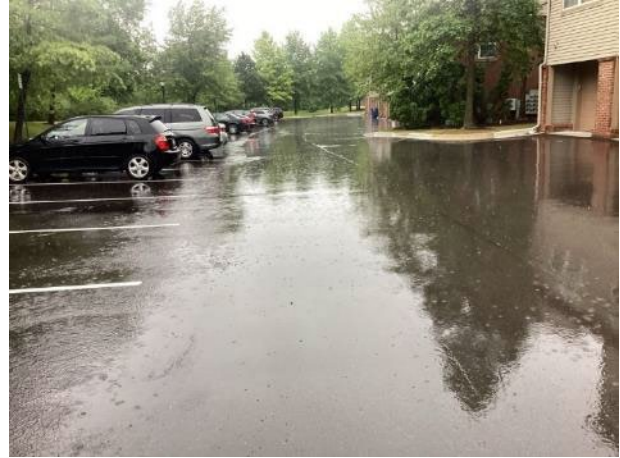
Pavement overview (2023 replacement)

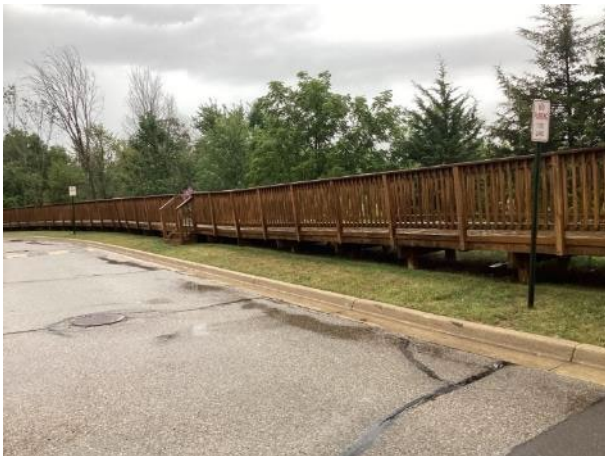
Condition: Poor overall with frequent deflection, rot and deterioration evident.

Boardwalk overview

History: The Association plans to replace the boardwalk in 2025 for a total cost of approximately \$115,000.

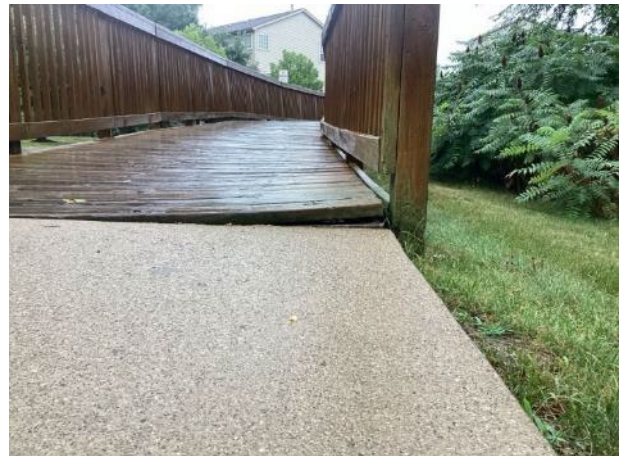
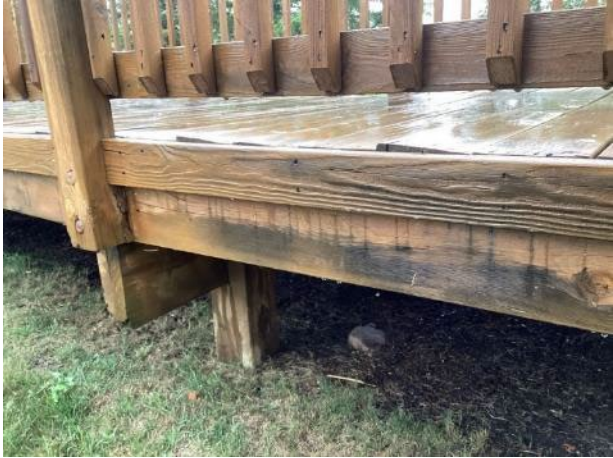
Deck board deflection

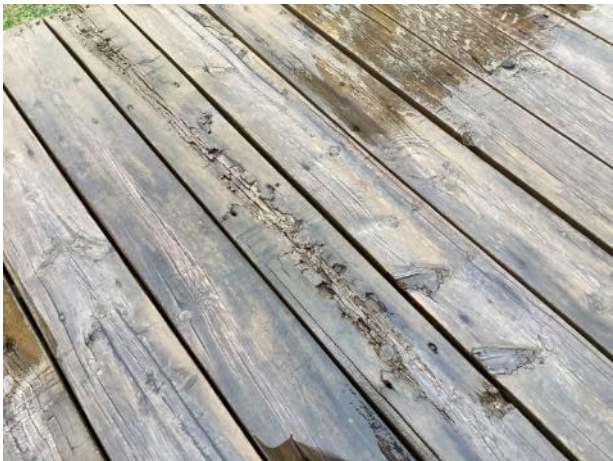
Deck board rot

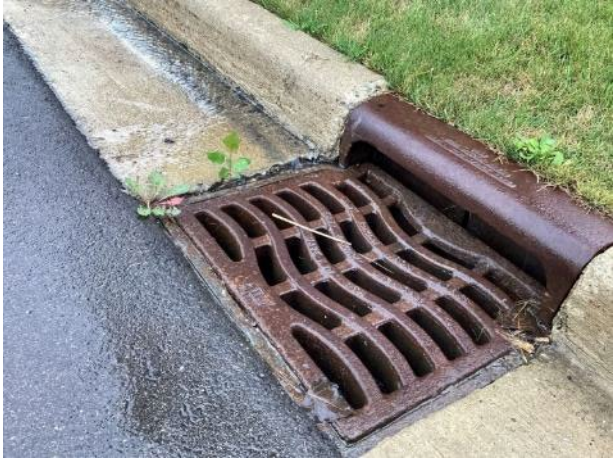
Condition: Fair overall with settlement evident.

Catch basin with minor settlement

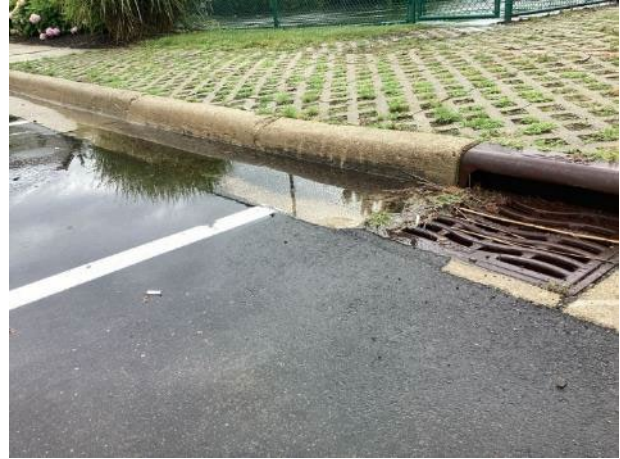
Debris accumulation near catch basin and negative drainage

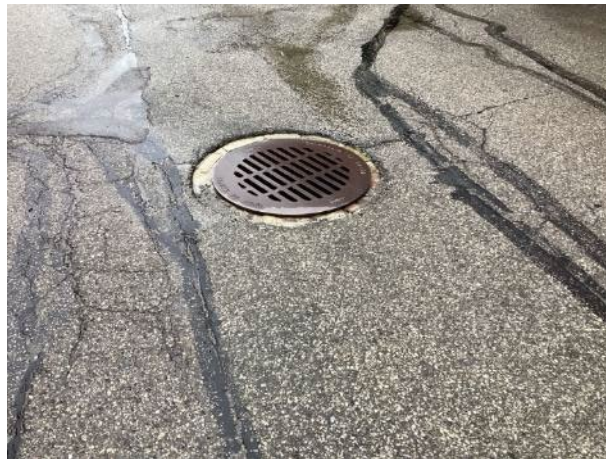
Catch basin settlement

Component Detail Notes: Erosion causes settlement around the collar of catch basins. Left unrepaired, the entire catch basin will shift and need replacement.

Expenditure Detail Notes: Expenditure timing and costs are depicted in the **Reserve Expenditures** table in Section 3. We recommend the Association plan for inspections and capital repairs to the catch basins in conjunction with repaving.

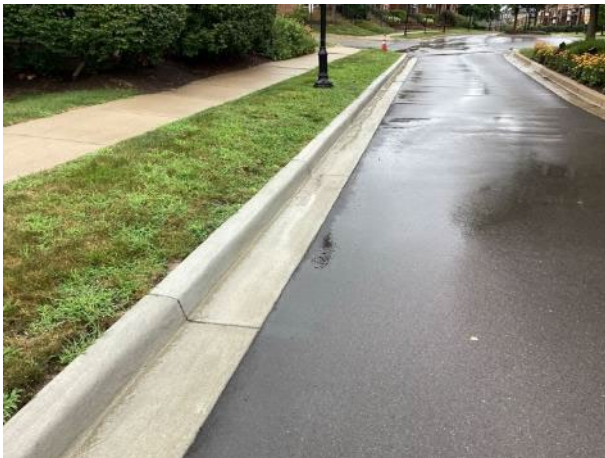
History and Condition: Fair overall with periodic cracks, settlement, spalled concrete, heaves, damage and previous repairs evident. The Association previously replaced sections of concrete curbs and gutters during the 2023 repaving event totaling approximately \$100,000.

Concrete curb and gutter
