Barclay Park Condominium

Inspected: August 6, 2024 • Revised on: May 23, 2025
Ann Arbor, MI

RESERVE STUDY

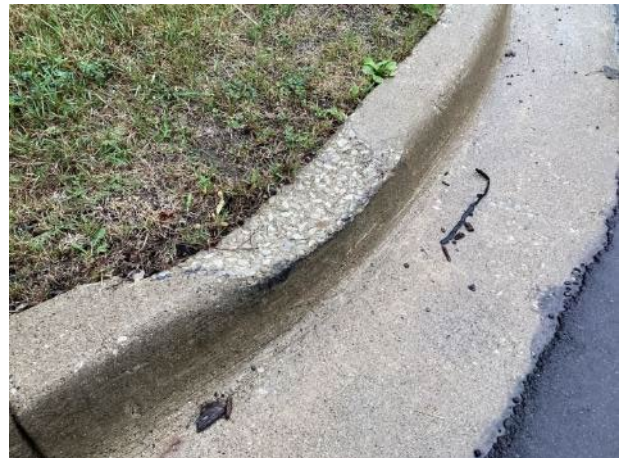
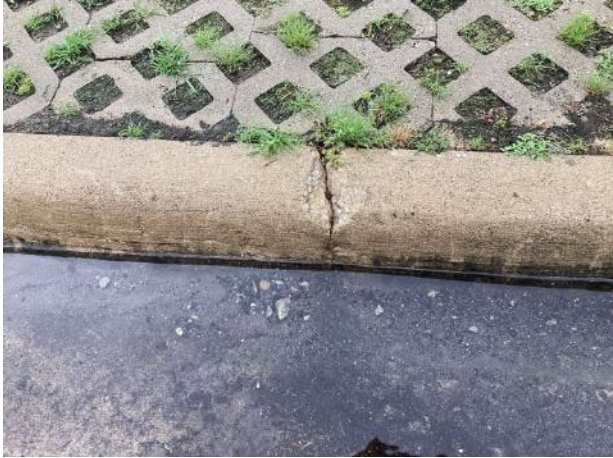
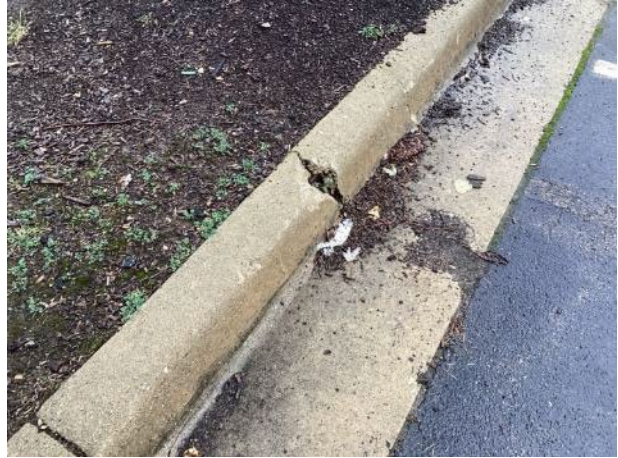
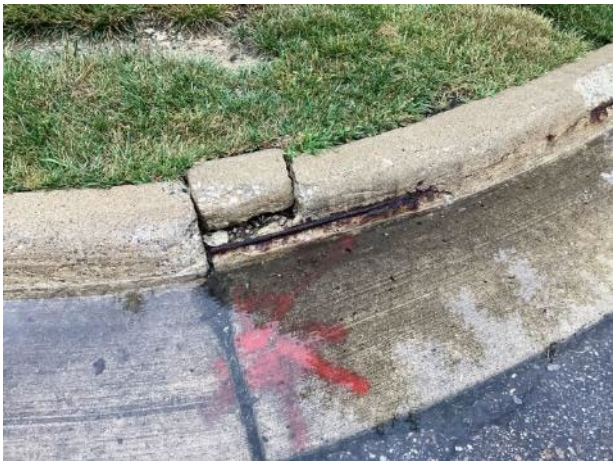
Concrete spalls

Expenditure Detail Notes: Expenditure timing and costs are depicted in the **Reserve Expenditures** table in Section 3. We estimate that up to 1,350 linear feet of curbs and gutters, or thirty-three percent (32.9%) of the total, will require replacement during the next 30 years.

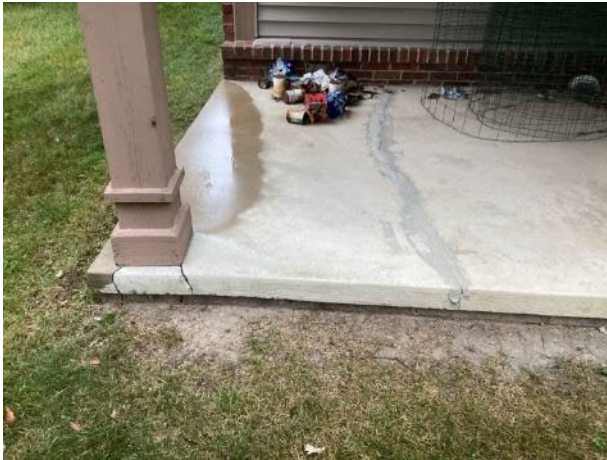
Patio cracks (unit 2804 shown)

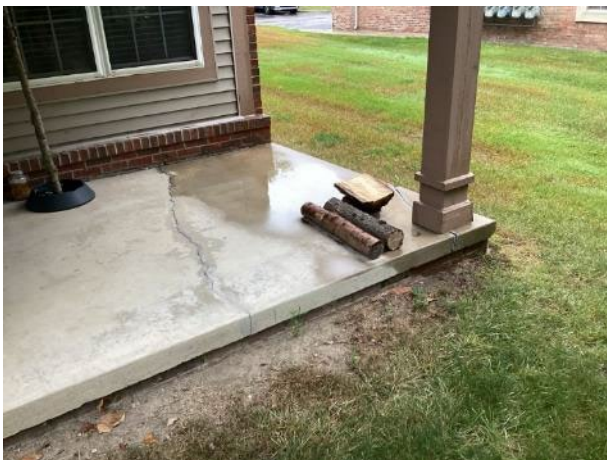
Patio cracks

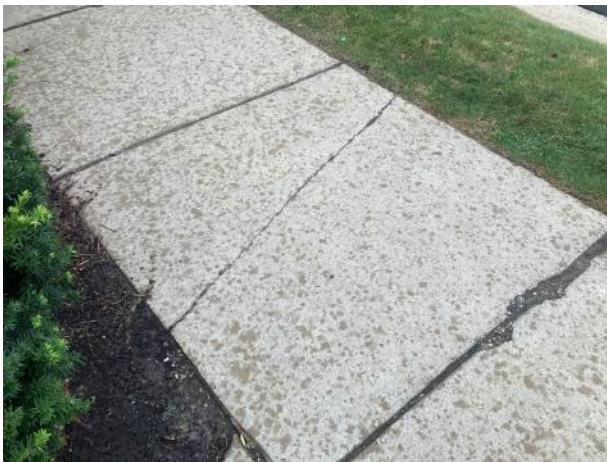
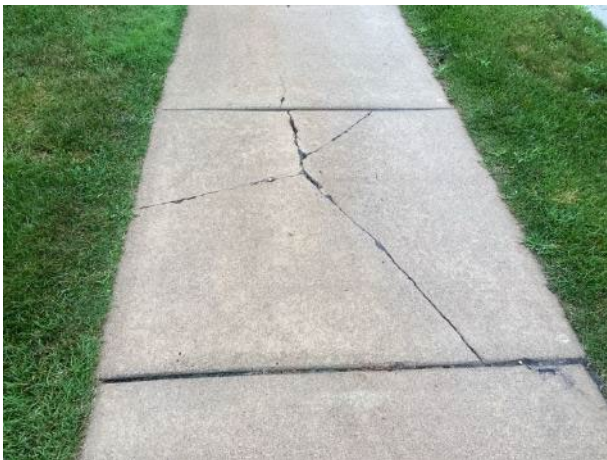
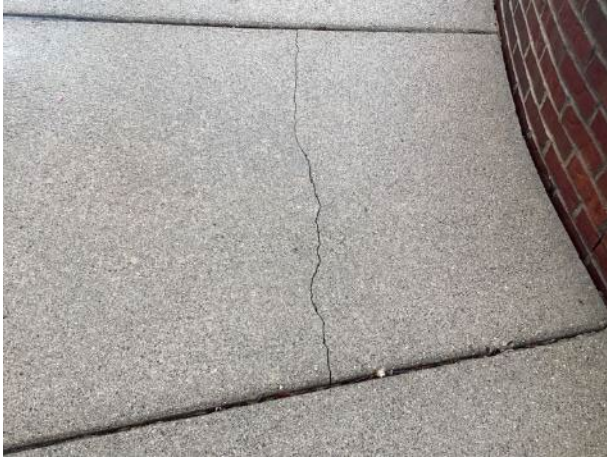
Sidewalk cracks

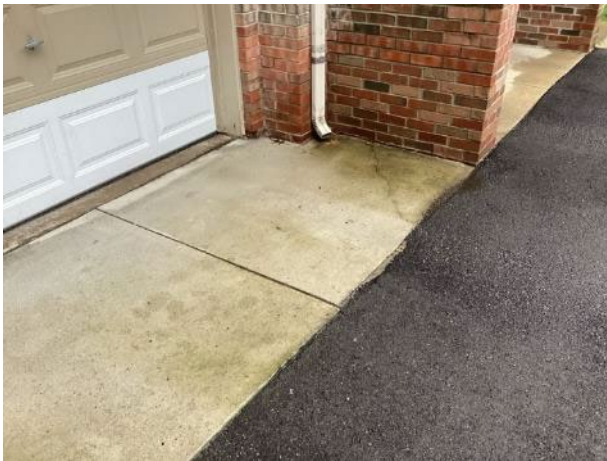
Garage apron cracks

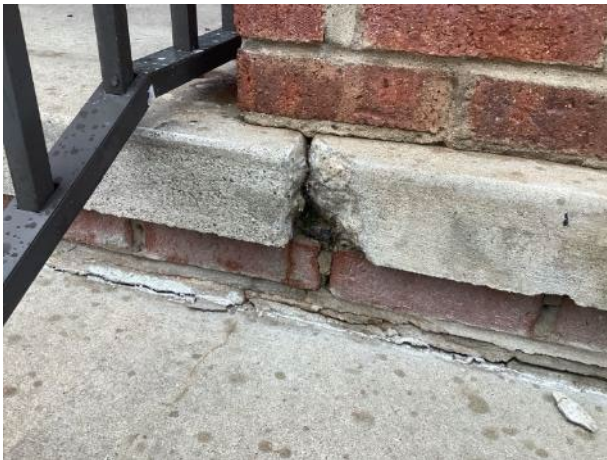
Stoop spall (clubhouse shown)

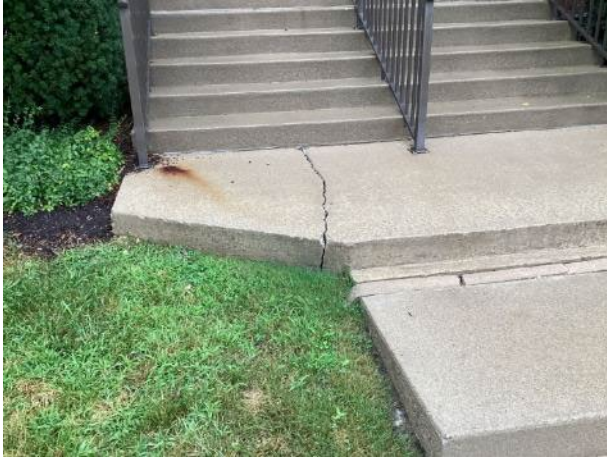
Concrete cracks

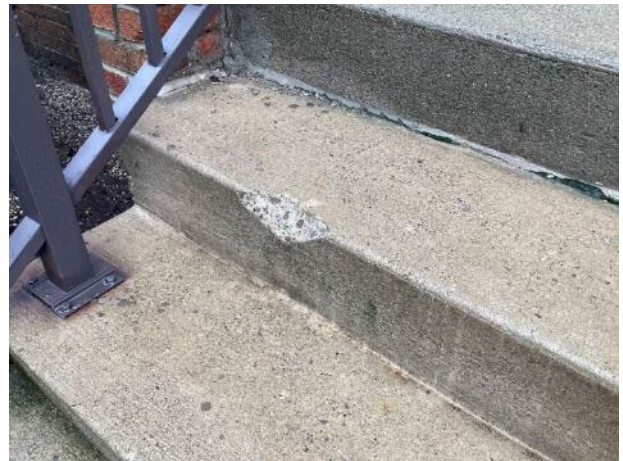
Stair spalls

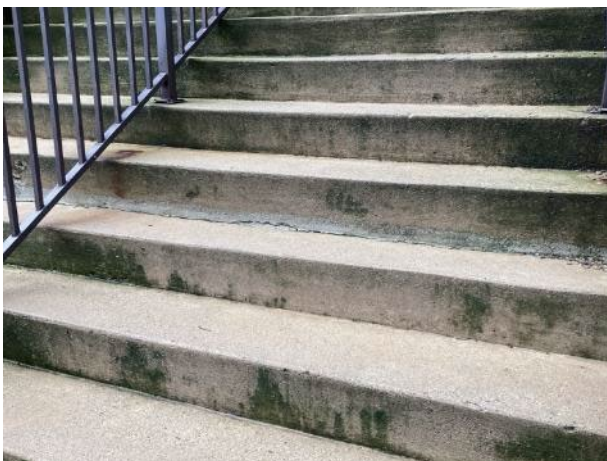
Stair cracks

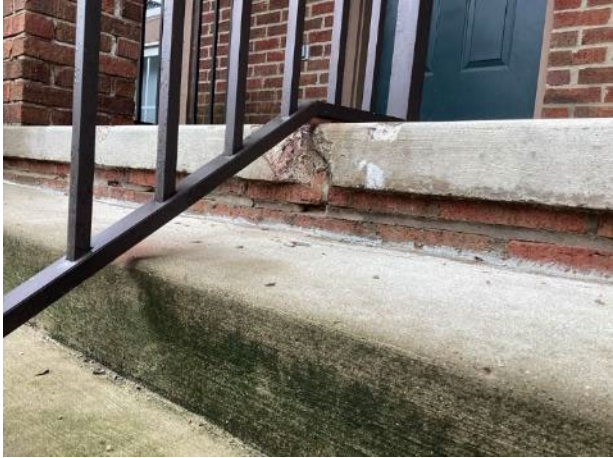
Landing spall

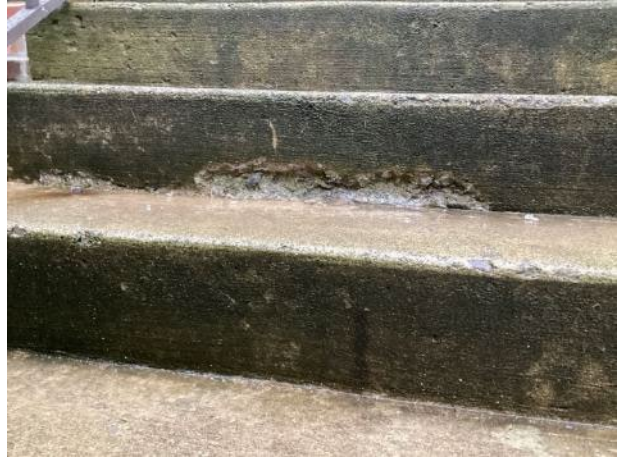
Stair spalls

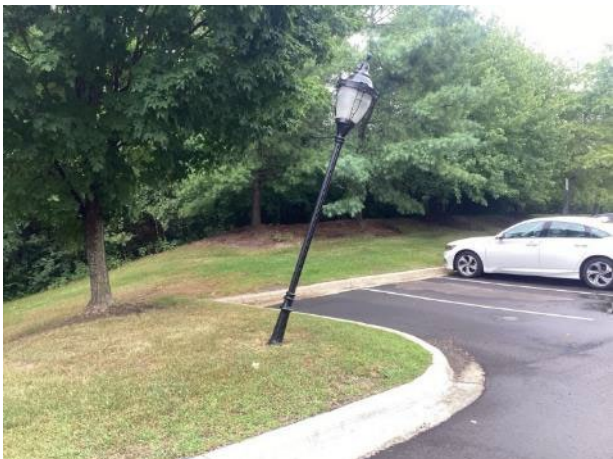
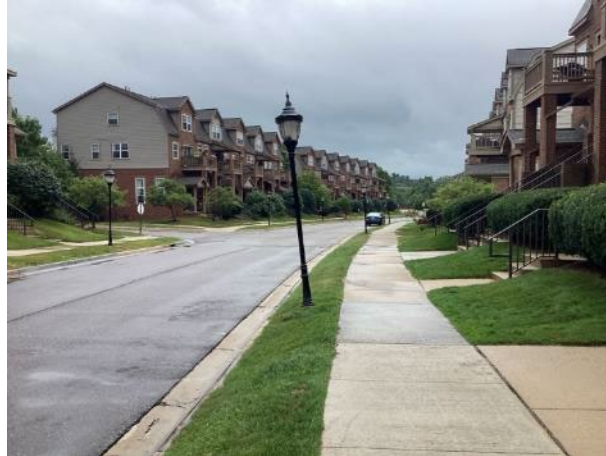
Condition: Fair overall with leaning poles evident.

Light pole lean

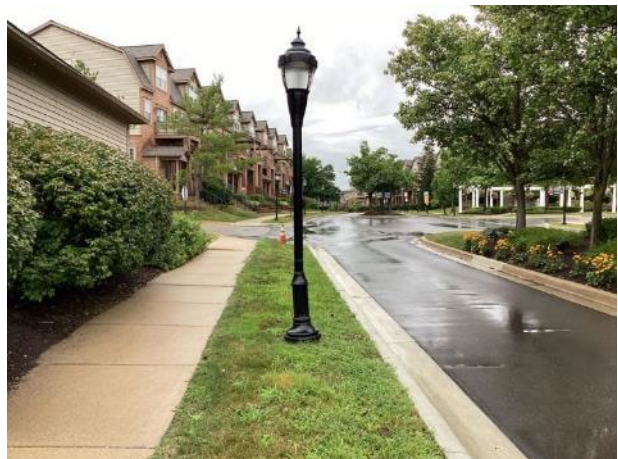
Light pole damage

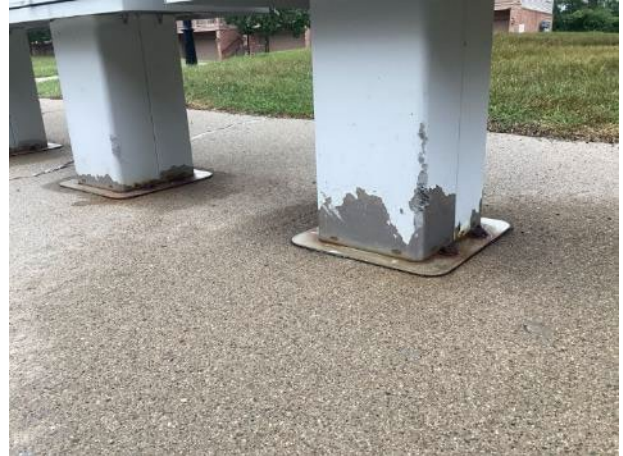
Condition: Fair overall with rust and finish deterioration evident.

Mailbox station finish deterioration and fastener rust

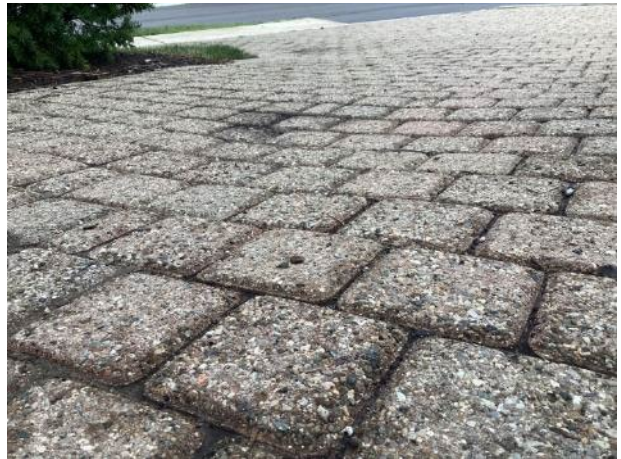
Condition: Fair overall with periodic settlement, spalled masonry and previous repairs evident.

Paver settlement

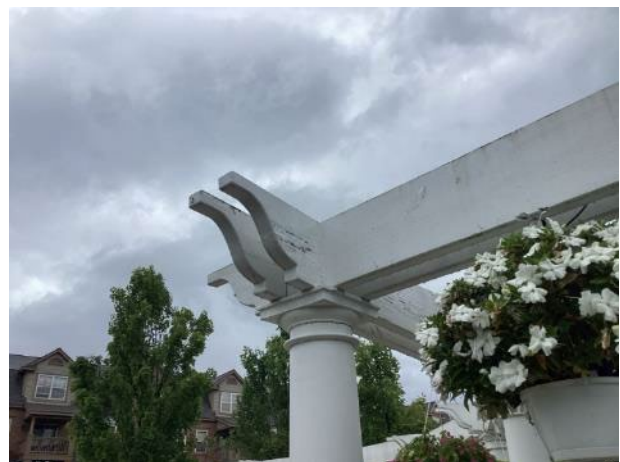
Condition: Fair to poor overall with frequent weathered wood, isolated displacement and damage evident.

Pergola weathered wood

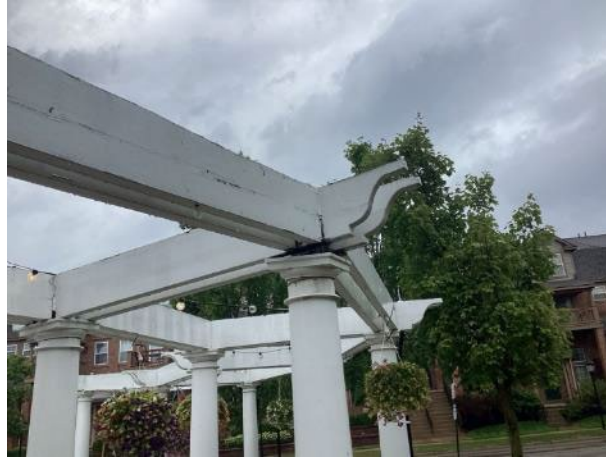
Pergola damage and displacement

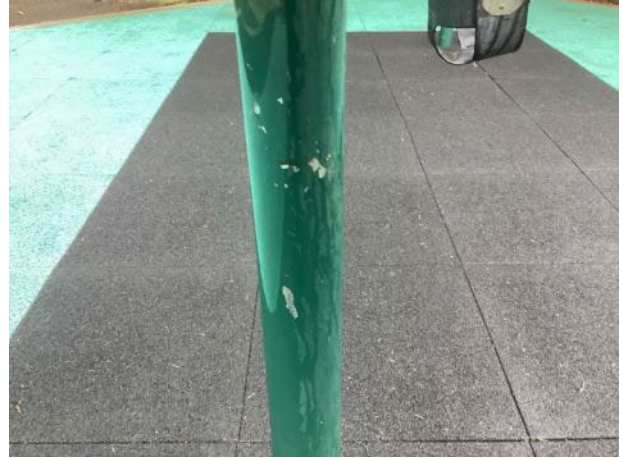
Condition: Good to fair overall with finish deterioration and rust evident.

Equipment finish deterioration

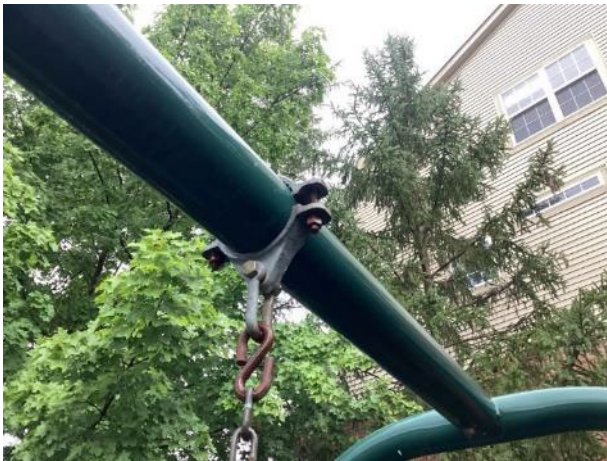
Fastener rust

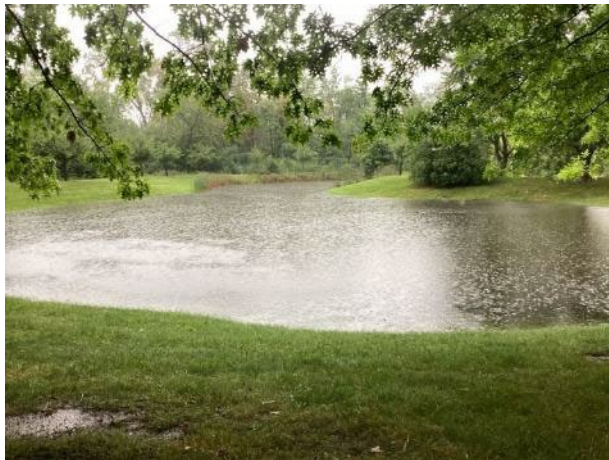
Condition: Good to fair visual condition. We note vegetative accumulation at the center pond. We also note evidence of soil movement at the shores/banks. The Association should maintain the shores/banks as normal maintenance with funds through the operating budget.

Center pond overview

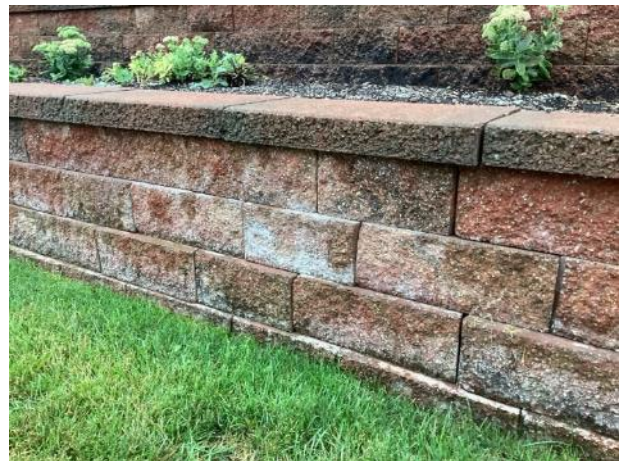
Condition: Good to fair overall with isolated efflorescence, settlement and spalls evident.

Wall efflorescence

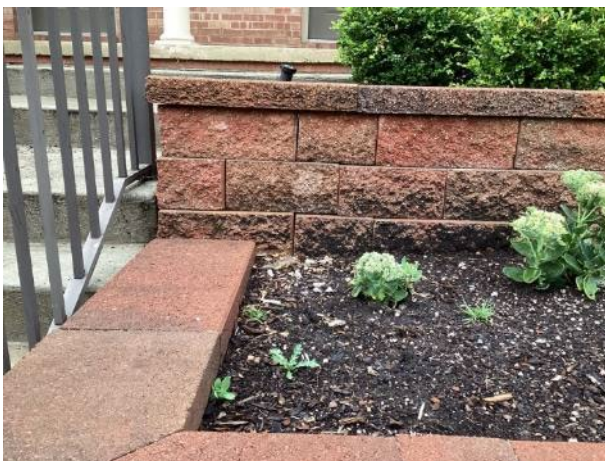
Wall block settlement

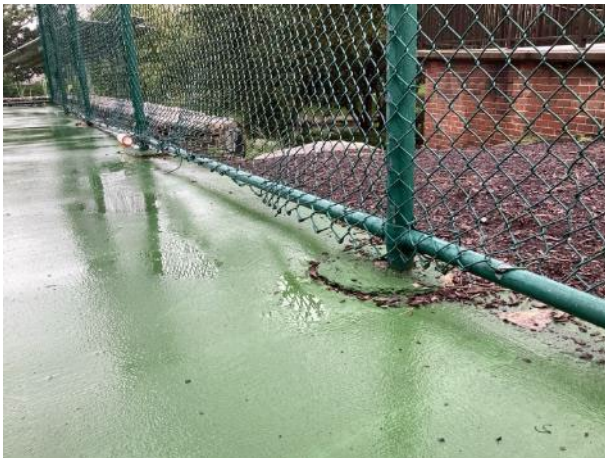
Condition: Fair to poor overall with finish deterioration, damage and warped webbing evident.

Fence warped webbing

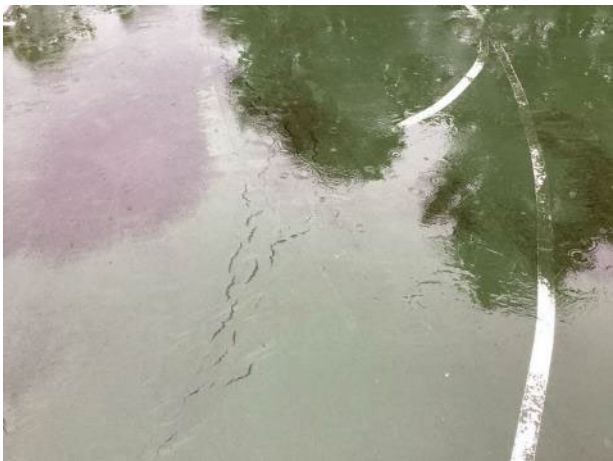
Condition: Poor overall with cracks, settlement, poor drainage, standards damage and color coat fade evident.

Surface cracks

Preventative Maintenance Notes: Prior to the application of the color coat, the Association should require the contractor to rout and fill all cracks with hot emulsion. This deters water infiltration and further deterioration of the asphalt playing surface. We note the following select recommended preventative maintenance activities to maximize the remaining useful life:

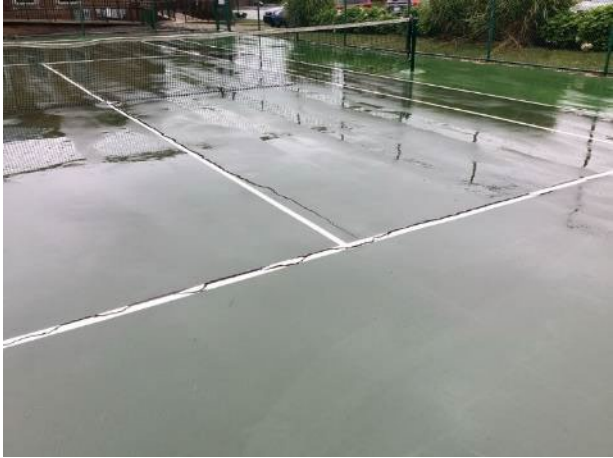
Surface cracks

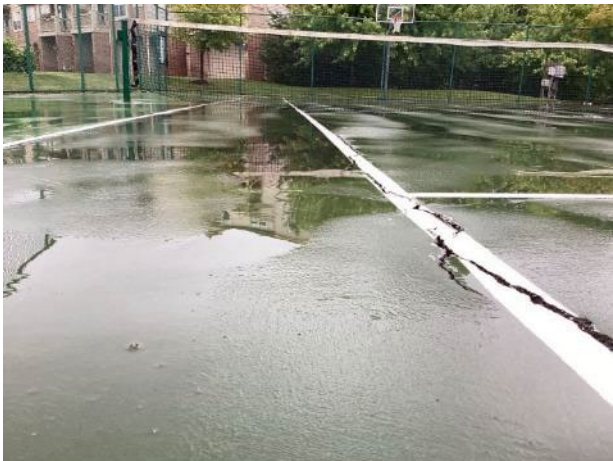
Court settlement and cracks

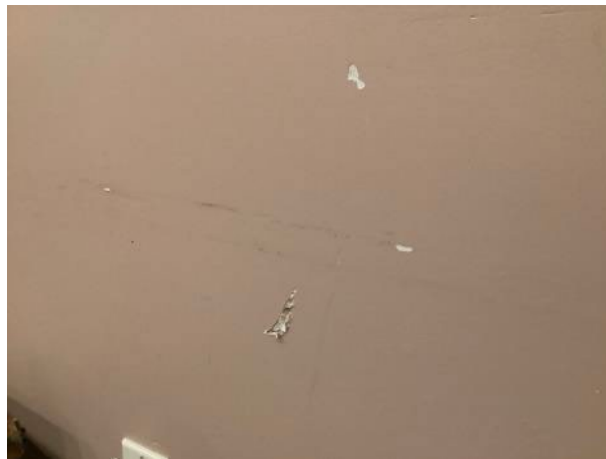
Paint damage

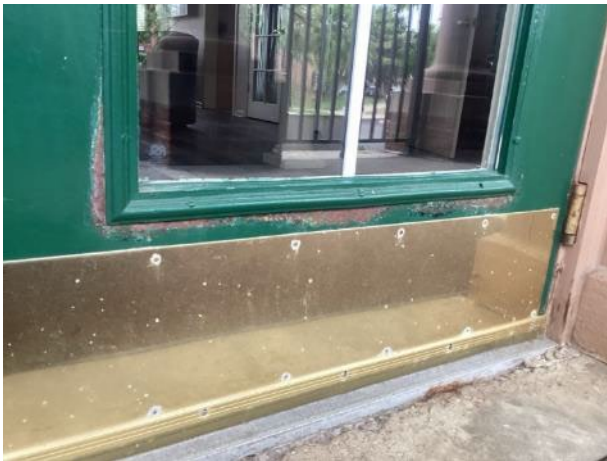
Condition: Fair to poor overall with frame finish deterioration evident.

Finish deterioration

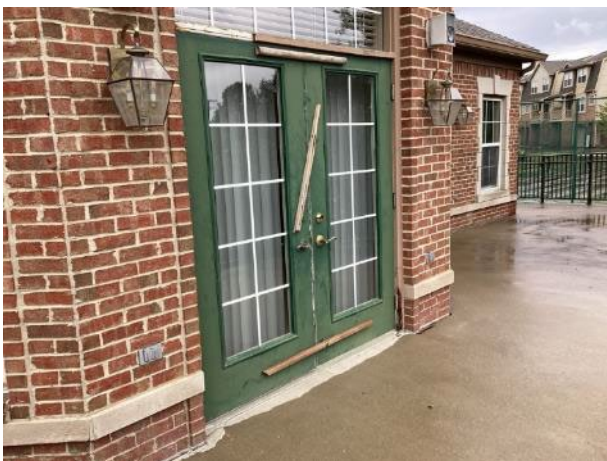
History: Original; The rear entry door at the clubhouse needs replaced.

Rear door in need of replacement
